Instrument Panel Support Description

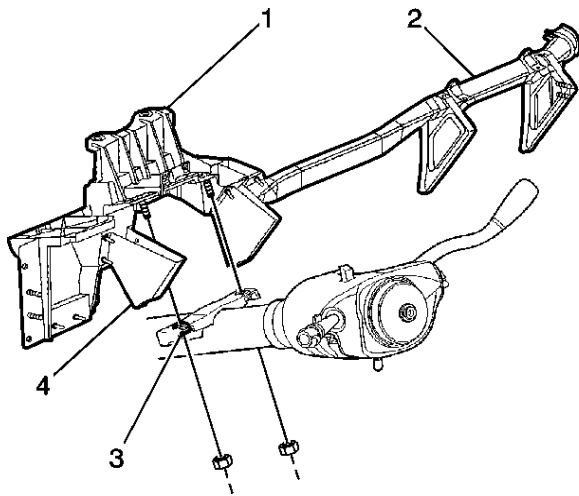
- The steering column capsules (3) have released or the column has collapsed.
- The steel knee bolster brackets (4) are bent.
- The parts which attach to the magnesium support do not fit.

The instrument panel support is comprised of a magnesium steering column support (1) and die-formed tube (2). The assembly functions as a structural cross-vehicle beam, an air-bag support, and an instrument panel carrier. The assembly consolidates many different steel and plastic components. The magnesium instrument panel support is designed in order to deform and absorb the energy generated by a severe impact.

Under no circumstance is the magnesium support to be repaired in any way. The magnesium support must be replaced if any of the following conditions are present after a collision:
