Tie Bar Replacement - Left

Removal Procedure

Tie Bar Replacement - Lower

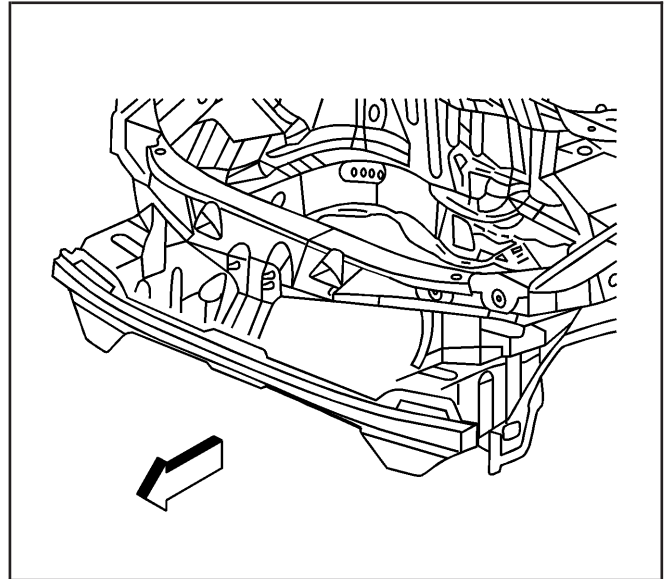
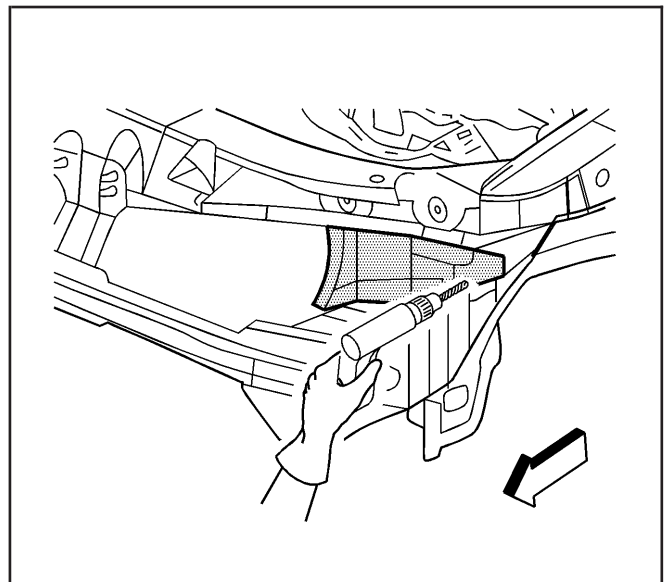
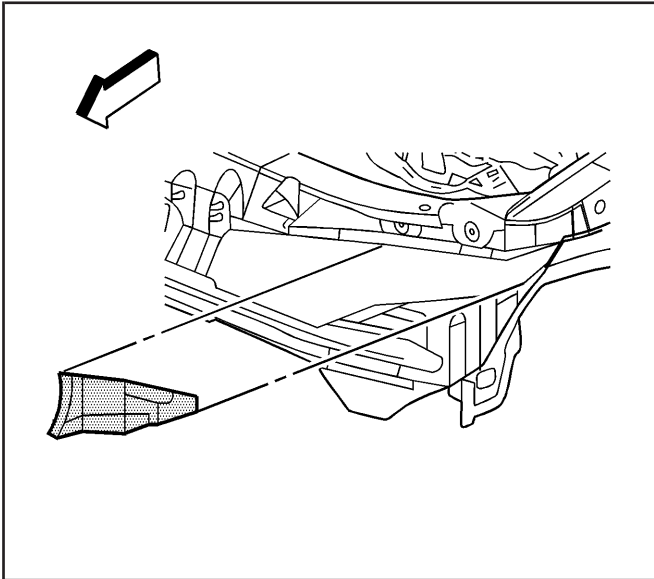
Important: Note the number and location of the factory welds for installation of the tie bar-left.

6. Locate and drill out all the necessary factory welds.

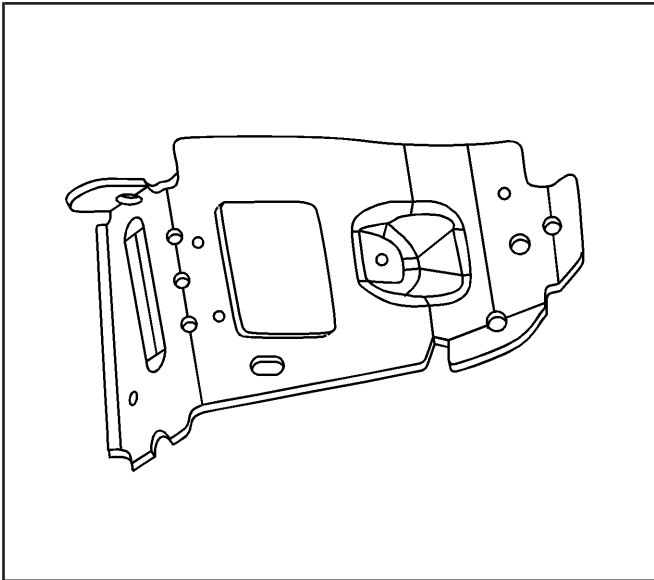
7. Remove the left tie bar.

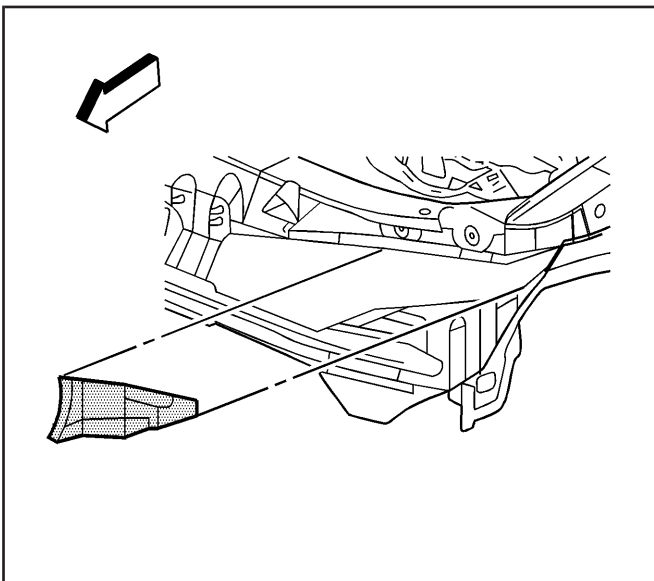
4. Position the left tie bar to the vehicle using 3-dimensional measuring equipment. Clamp the tie bar in place.

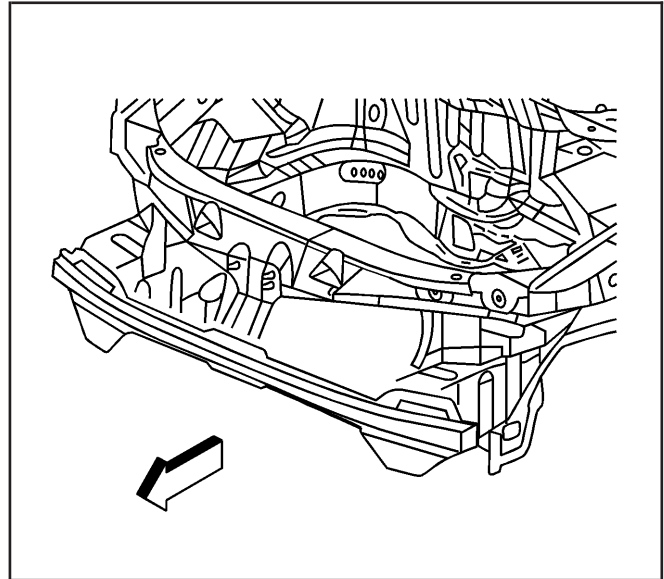
5. Plug weld accordingly.
6. Clean and prepare all of the welded surfaces.
7. Install all of the related panels and components.
8. Apply the sealers and anti-corrosion materials to the repair area, as necessary.
9. Paint the repaired area.
10. Connect the negative battery cable.
11. Enable the SIR system.

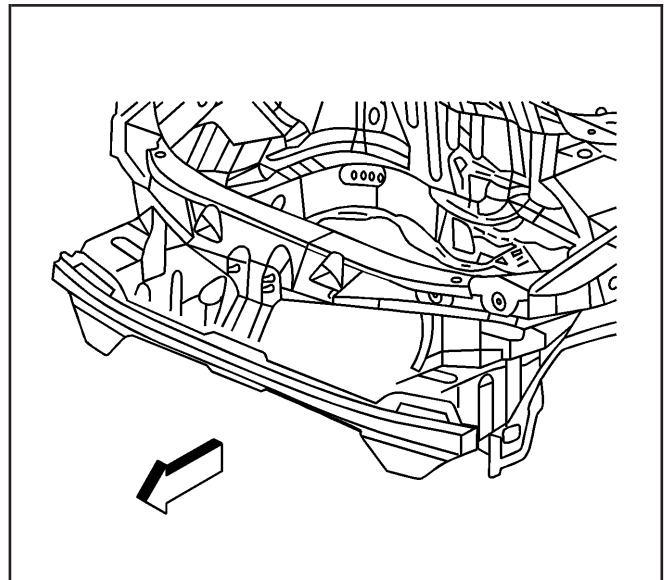
Important: This panel is replaced at factory seams or can be unbolted for removal.

3. Remove all related panels and components.
4. Repair as much of the damage as possible. Refer to *Dimensions - Body* on page 3-7.
5. Remove the sealers and anti-corrosion materials from the repair area, as necessary.
