Front Compartment Upper Side Rail Replacement

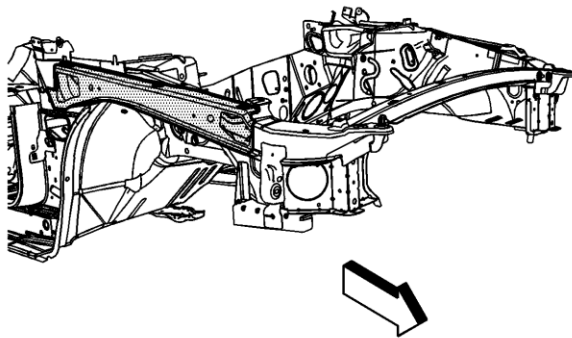
1. Disable the SIR system. Refer to [SIR Disabling and Enabling](#) .
2. Disconnect the negative battery cable. Refer to Battery Negative Cable Disconnection and Connection .
3. Remove all related panels and components.
4. Repair as much of the damage as possible to factory specifications. Refer to [Dimensions - Body](#) .
5. Remove the sealers and anti-corrosion materials from the repair area. Refer to [Anti-Corrosion Treatment and Repair](#) .

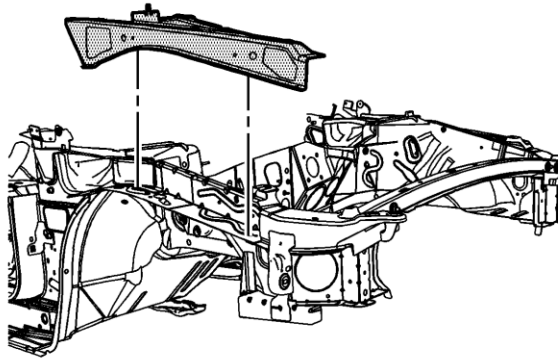
6. Locate and drill out all factory welds. Note the number and location of the welds for installation of the front upper rail.

7. Remove the damaged front upper rail.

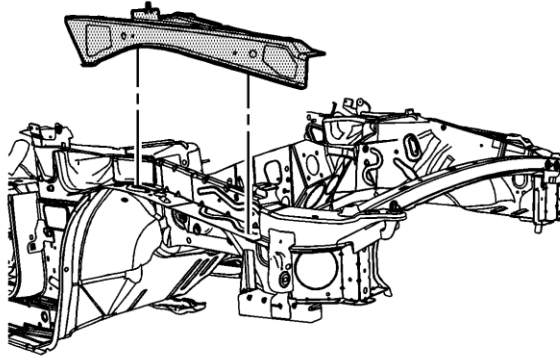
4. Position the front upper rail on the vehicle using 3-dimensional measuring equipment. Clamp the rail in place.

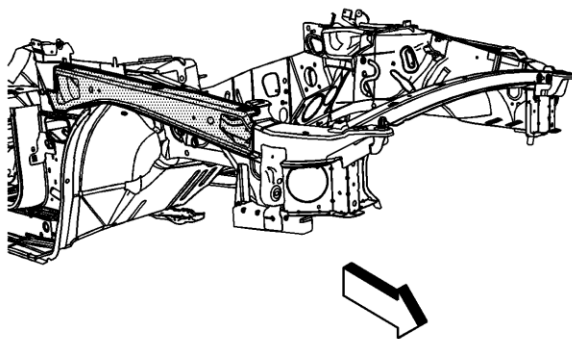
5. Plug weld accordingly.
6. Clean and prepare all welded surfaces.
7. Install all related panels and components.
8. Apply the sealers and anti-corrosion materials to the repair area, as necessary. Refer to [Anti-Corrosion Treatment and Repair](#).
9. Paint the repair area. Refer to [Basecoat/Clearcoat Paint Systems](#).
