Quarter Inner Panel Replacement

Removal Procedure

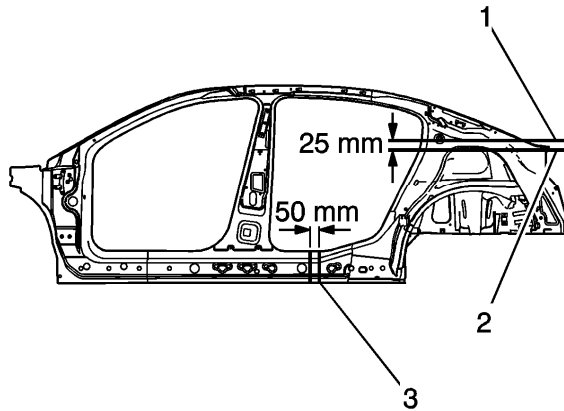
Important: Do not damage any inner panels or reinforcements.

- Locate the horizontal wheel housing top flat area in the upper quarter area (1).
- Measure up 25 mm (1 in). Scribe a cut line (2).
- On the vehicle rocker area, locate and scribe a vertical cut line in the recommended section area (3).

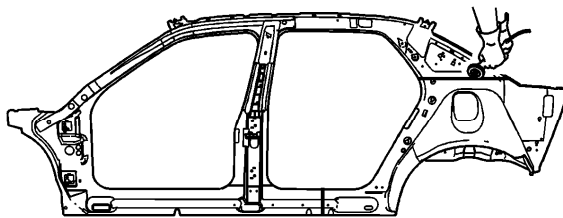
- Cut the panel to be sectioned.

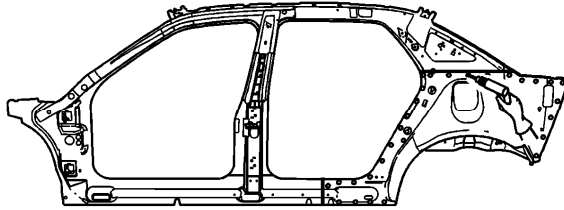
Important: Note the number and location of the factory welds for installation of the inner quarter panel.

11. Locate, mark, and drill out all the necessary factory welds.

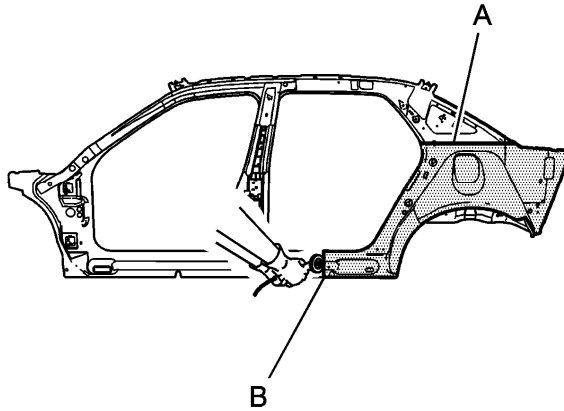
1. Cut the service part in the corresponding locations to the sectioning cuts. Allow for a 50 mm (2 in) overlap at the wheelhouse (a) and the rocker panel (b).

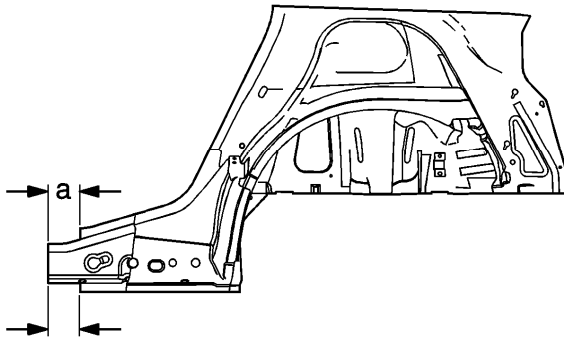
2. At the cut edge of the service rocker panel, measure rearward 50 mm (2 in) (a). Notch out the rocker panel flange to allow an overlap to the rocker.

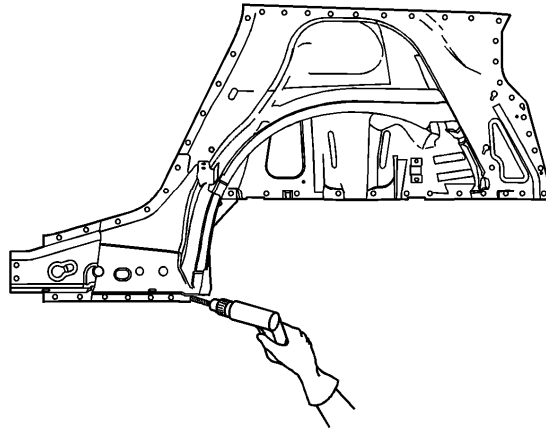
3. Drill 8 mm (5/16 in) plug weld holes along the sectioning cut on the original reinforcement. Locate these holes 25 mm (1 in) from the edge and spaced 40 mm (1½ in) apart.

Important: If the location of the original plug weld holes can not be determined, space the plug weld holes every 40 mm (1 1/2 in) apart.

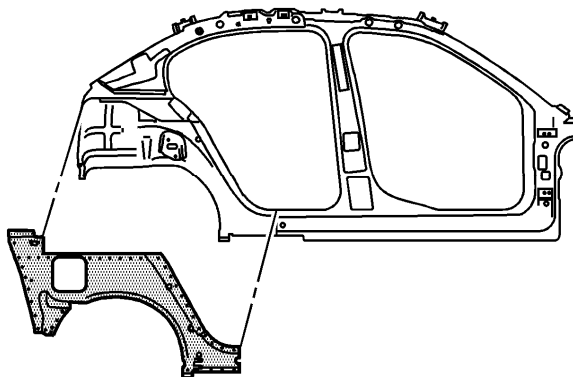
7. Align the service part on the vehicle using 3-dimensional measuring equipment.

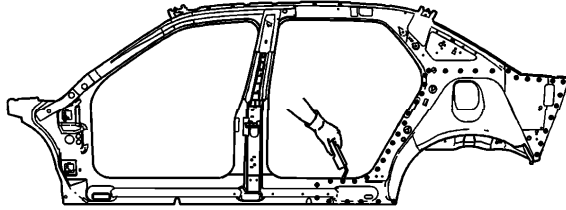
8. Plug weld accordingly.
9. To create a solid weld with minimum heat distortion, make 25 mm (1 in) stitch welds along the seam with 25 mm (1 in) gaps between them. Go back and complete the stitch weld.
10. Clean and prepare all of the welded surfaces.
11. Apply the sealers and anti-corrosion materials to the repair area, as necessary. Refer to [Anti-Corrosion Treatment and Repair](#) .
12. Paint the repaired area. Refer to [Basecoat/Clearcoat Paint Systems](#) .
13. Install all of the related panels and components.
14. Connect the negative battery cable. Refer to [Battery Negative Cable Disconnection and Connection](#) .
15. Enable the SIR system. Refer to [SIR Disabling and Enabling](#) .
