Front Wheelhouse Sectioning

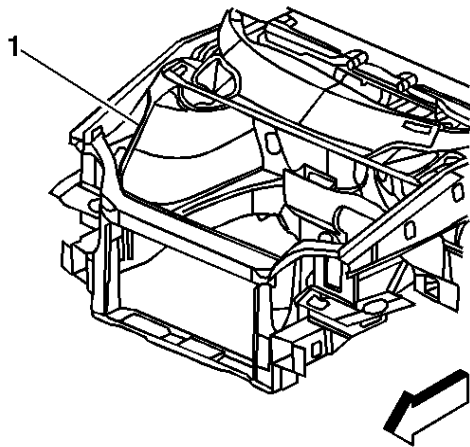
1. Remove all related panels and components.
2. Restore as much of the damage as possible to factory specifications.
3. Note the location and remove the following as necessary:
 - Sealers
 - Sound deadeners
 - Anti-corrosion materials (1)

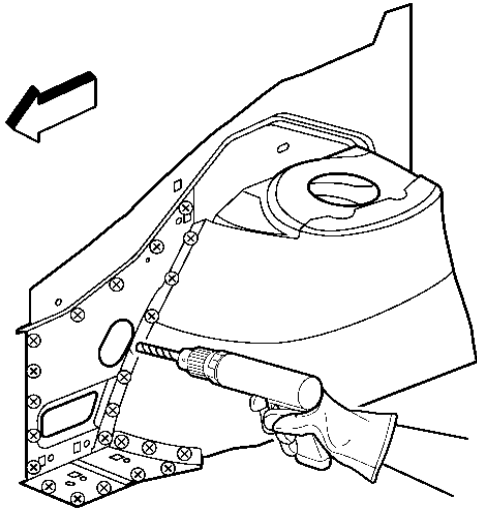
Important: Do not damage any inner panels or reinforcements.

4. Locate and drill out all factory welds. Note the number and location of welds for installation of the service part.

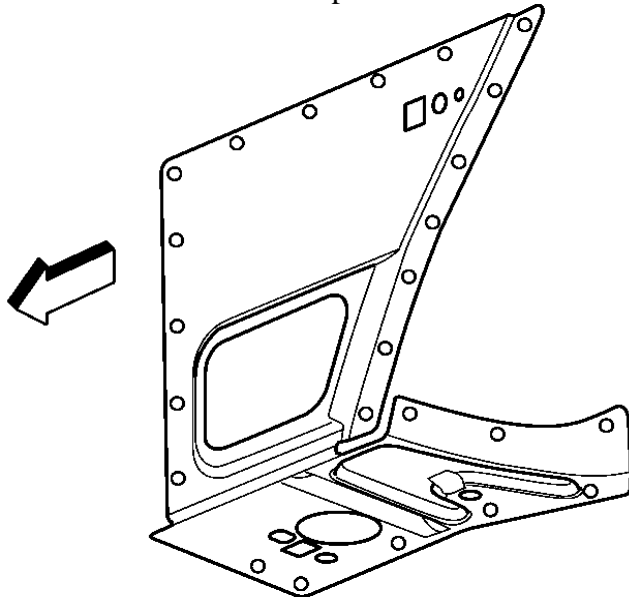
5. Remove the damaged apron extension.

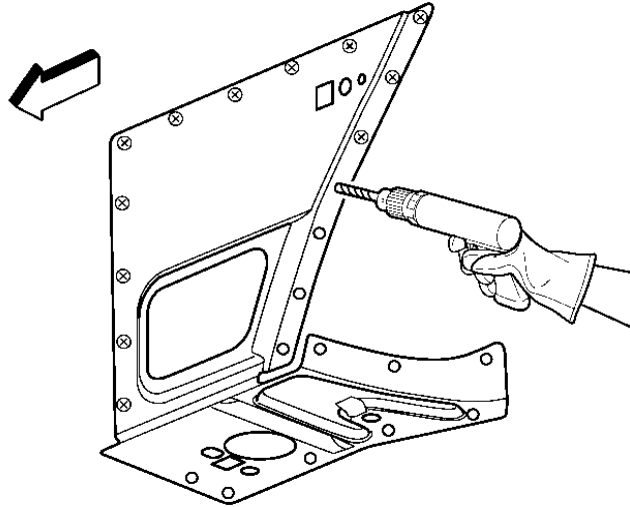
Important: In any area damaged beyond recognition, space plug weld holes every 40 mm (1 ½ in) apart.

1. Drill 8 mm (5/16 in) plug weld holes in the service part as necessary in the locations noted from the original panel and along the sectioning cut.
2. Prepare all attachment surfaces as necessary.

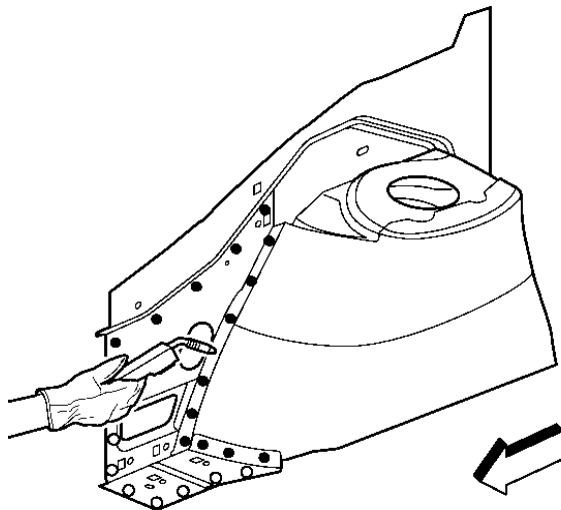
3. Apply GM-approved Weld-Thru Coating or equivalent to all mating surfaces. Refer to [Anti-Corrosion Treatment and Repair](#) .
4. Position the apron extension.
5. Plug weld accordingly.
6. Clean and prepare all welded surfaces.

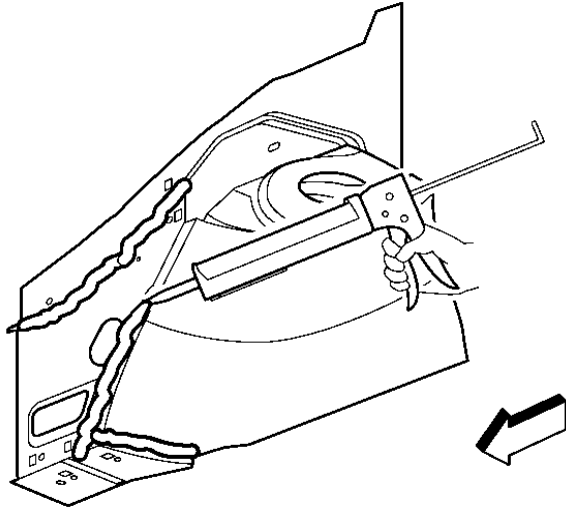
7. Apply the following as necessary:
 - Anti-corrosion materials
 - Sound deadening materials
 - Sealers
10. Refinish as necessary.
11. Install all related panels and components.
