Front Compartment Upper Side Rail Replacement

Removal Procedure

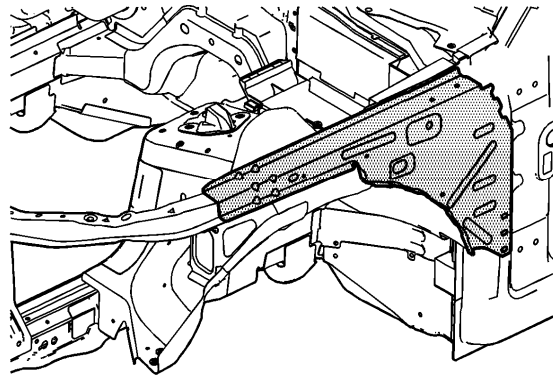
Important: Sectioning of the front upper rails is not recommended.

3. Remove all related panels and components.
4. Restore as much of the damage as possible .
5. Remove the sealers and anti-corrosion materials from the repair area, as necessary. Refer to [Anti-Corrosion Treatment and Repair](#) in Paint and Coatings.

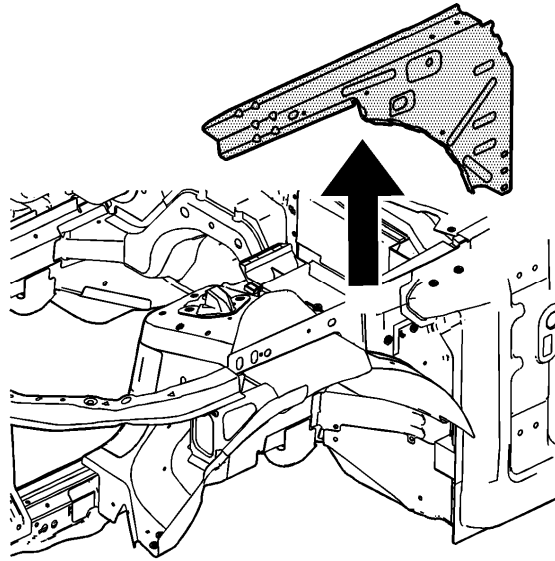
6. Locate, mark, and drill out all factory welds attaching the outer rail.

7. Remove the damaged outer rail.
