Pillar Replacement - Center Reinforcement

Removal Procedure

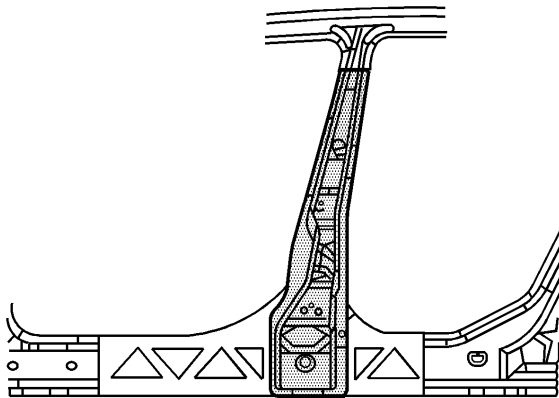
Caution: Sectioning should be performed only in the recommended areas. Failure to do so may compromise the structural integrity of the vehicle and cause personal injury if the vehicle is in a collision.

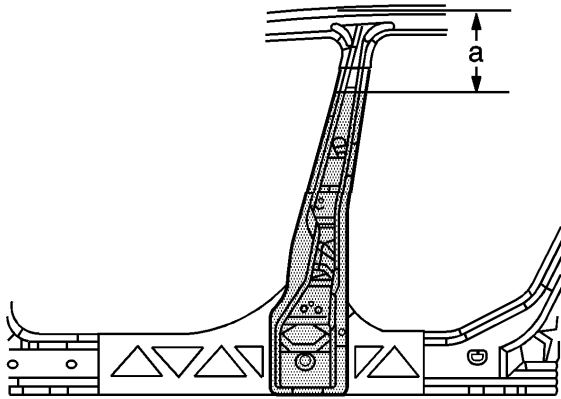
7. Measure down (a) 220 mm (8 5/8 in) from the edge of the door opening. Create a cut line.

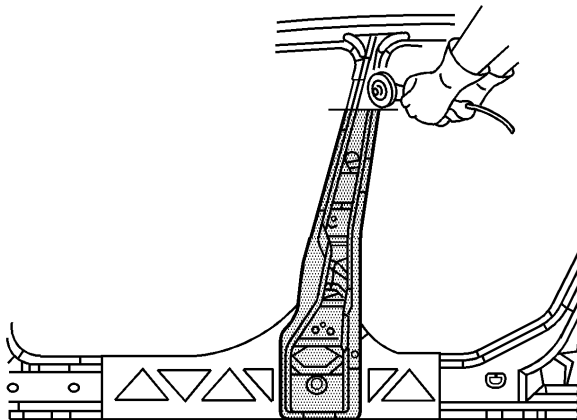
- Cut the panel where sectioning is to be performed.

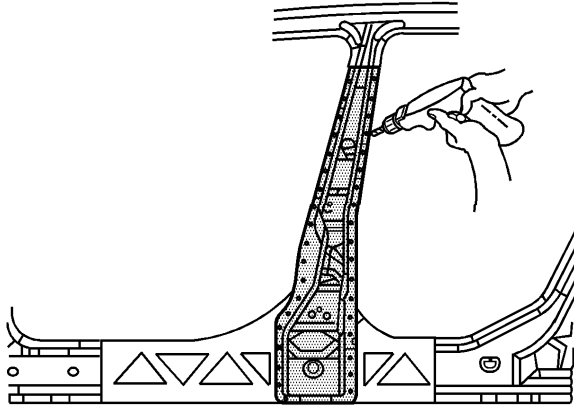
Note the number and location of the factory welds for installation of the center pillar.

- Locate, mark, and drill out all the necessary factory welds.

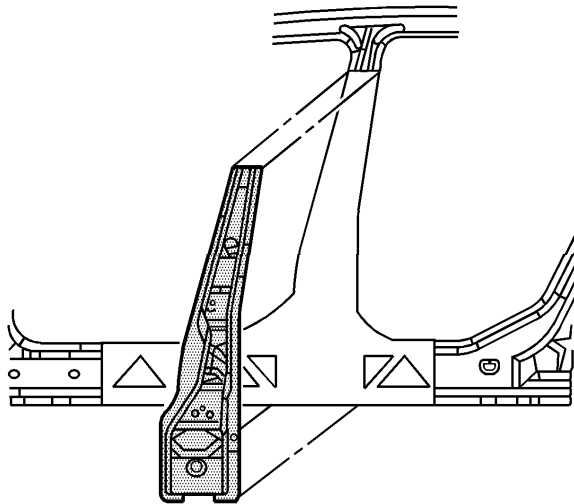
- Remove the damaged front pillar.

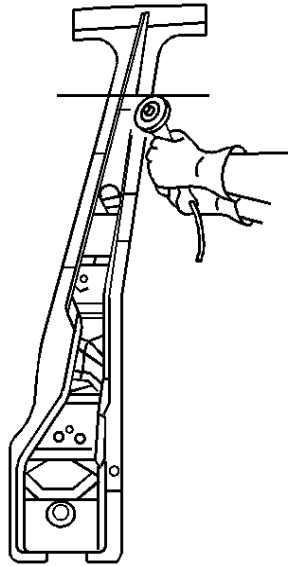
1. Measure the service part 30 mm (1 3/16 in) longer than the original reinforcement to allow for an overlap.
2. Cut the service part at this sectioning location.

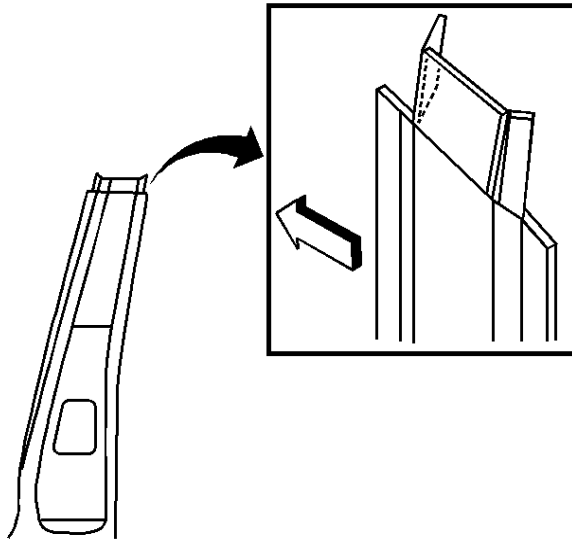
3. Cut the service part in the corners as shown and step the tabs inward to allow the service part to fit under the original reinforcement.

4. Drill 8 mm (5/16 in) plug weld holes along the sectioning cut on the original reinforcement. Locate these holes 13 mm (1/2 in) from the edge and spaced 40 mm (1 1/2 in) apart.

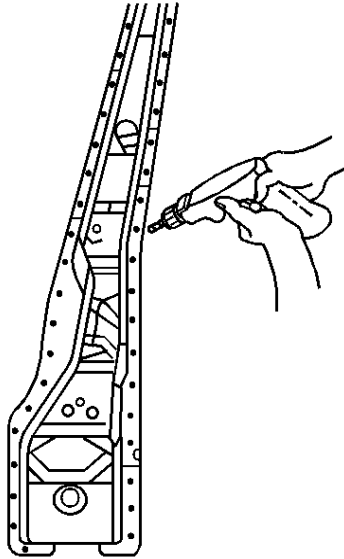
If the location of the original plug weld holes can not be determined, or if structural weld-thru adhesive is present, space the plug weld holes every 40 mm (1 1/2 in).

5. Drill 8 mm (5/16 in) plug weld holes in the service reinforcement, as necessary, in the locations noted from the original panel.
6. Prepare all mating surfaces, as necessary.
7. Apply GM-approved Weld-Thru Coating or equivalent to all mating surfaces. Refer to [Anti-Corrosion Treatment and Repair](#) .

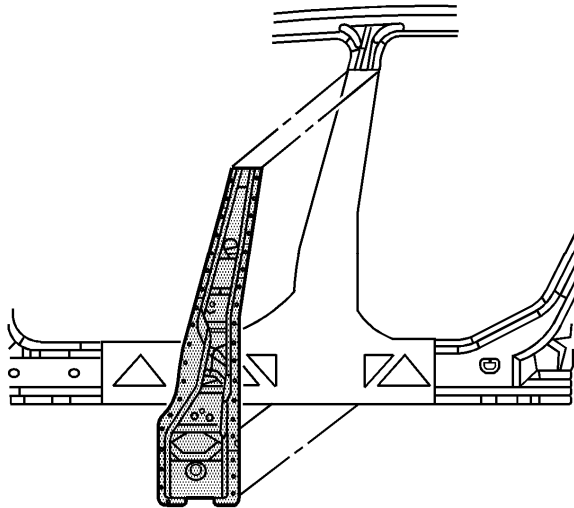
9. Align the service part on the vehicle using 3-dimensional measuring equipment.
10. Plug weld accordingly.
11. To create a solid weld with minimum heat distortion, make 25 mm (1 in) stitch welds along the seam with 25 mm (1 in) gaps between them. Go back and complete the stitch weld.
12. Clean and prepare all of the welded surfaces.
13. Apply the sealers and anti-corrosion materials to the repair area, as necessary. Refer to [Anti-Corrosion Treatment and Repair](#) in Paint and Coatings.
14. Paint the repaired area. Refer to [Basecoat/Clearcoat Paint Systems](#) in Paint and Coatings.
15. Install all of the related panels and components.
16. Connect the negative battery cable. Refer to [Battery Negative Cable Disconnect/Connect Procedure](#) in Engine Electrical.
17. Enable the SIR system. Refer to [SIR Disabling and Enabling Zones](#) in SIR.
