Rear Compartment Panel Sectioning

Removal Procedure

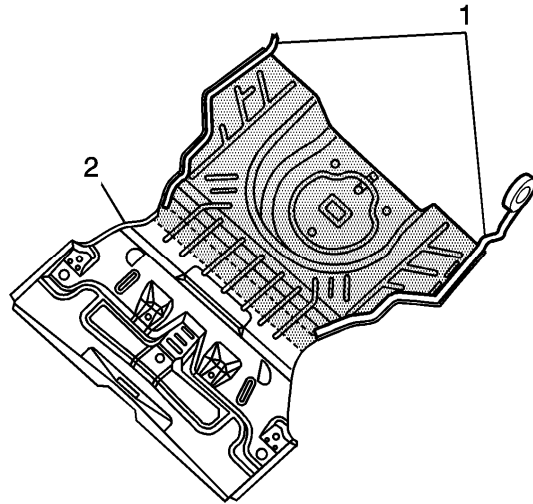
6. Apply a 25 mm (1 in) wide piece of masking tape (1) to the rear compartment panel along the contour of the wheelhouse, from the #5 crossbar to the rear of the compartment panel. Apply the tape on both sides of the rear compartment panel.

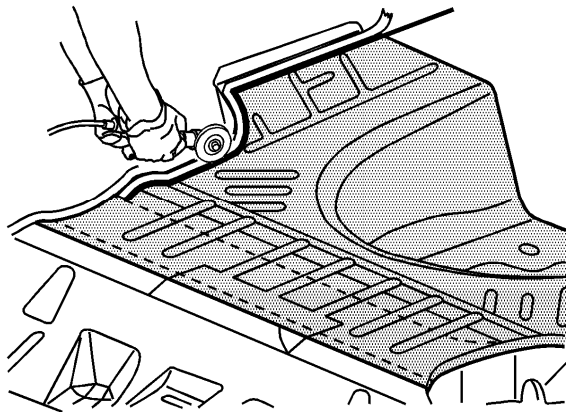
7. Cut along the inboard side of the tape to create a weld flange.

- Cut the rear compartment panel at the rear edge of the #5 crossbar.

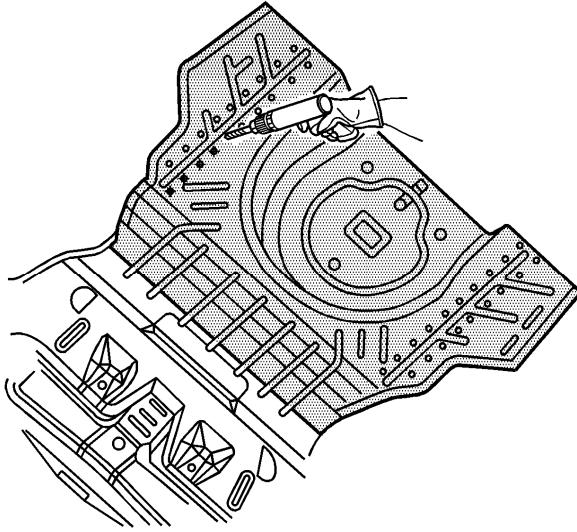
- Locate, mark, and drill out all factory welds. Note the number and location of welds for installation of the service assembly.
- Remove the damaged rear compartment panel from the vehicle.

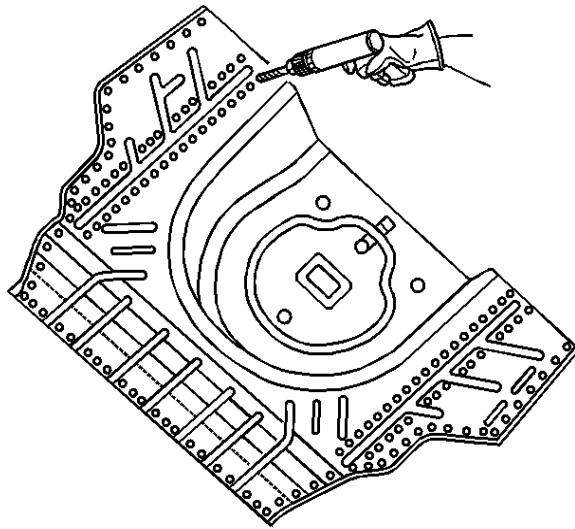
- Prepare the mating surfaces as necessary.
- Apply a 25 mm (1 in) piece of masking tape along the contour of the wheelhouse from the front edge to the rear edge of the rear compartment floor service part on both sides. Cut along the outside of the tape and remove the up-turned flange.
- Drill 8 mm (5/16 in) plug weld holes along the front edge of the service part spaced 40 mm (1 1/2 in) apart.

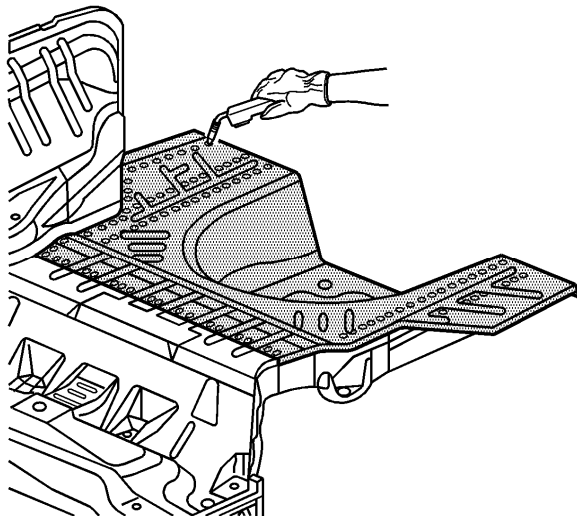
4. Drill 8 mm (5/16 in) plug weld holes in the service part, as necessary, in the locations noted from the original panel.
5. Apply GM-approved Weld-Thru Coating or equivalent to all mating surfaces. Refer to [Anti-Corrosion Treatment and Repair](#)
6. Install and align the service part using 3-dimensional measuring equipment.

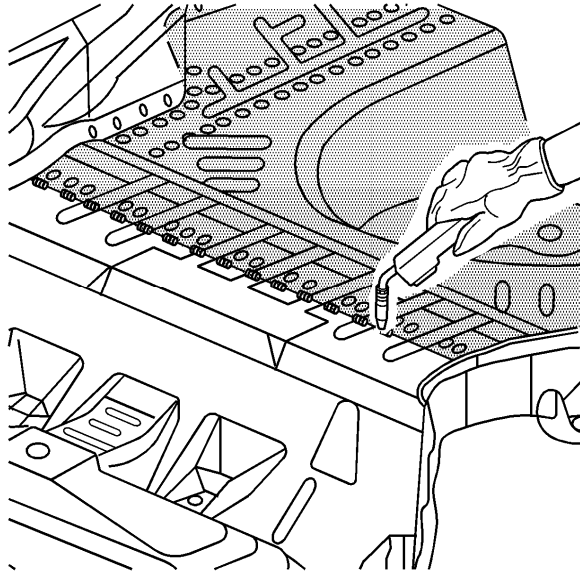
7. Plug weld accordingly.

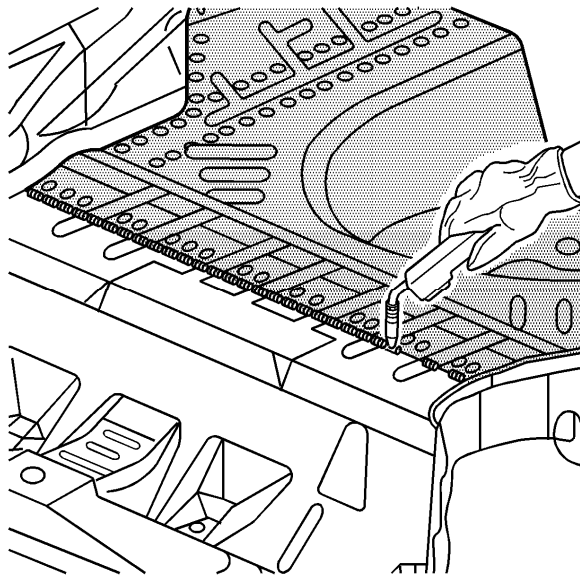
8. To create a solid weld along the front of the service part with a minimum of heat distortion, make a 25 mm (1 in) stitch weld along the seam with 25 mm (1 in) gaps between them.
