# Center Reinforcement Pillar Replacement

## Removal Procedure

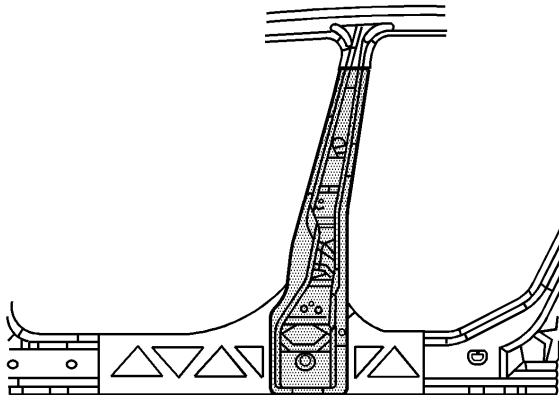
**Caution: Sectioning should be performed only in the recommended areas. Failure to do so may compromise the structural integrity of the vehicle and cause personal injury if the vehicle is in a collision.**

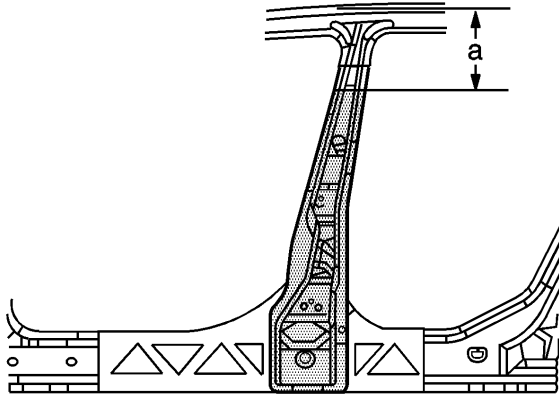
**Important:** Do not damage any inner panels or reinforcements.

7. Measure down (a) 220 mm (8 5/8 in) from the edge of the door opening. Create a cut line.

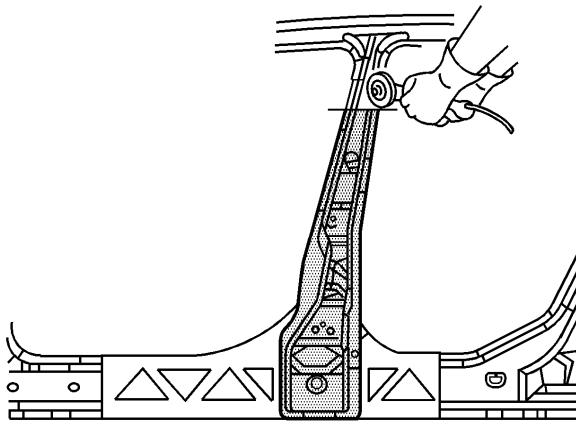
- Cut the panel where sectioning is to be performed.

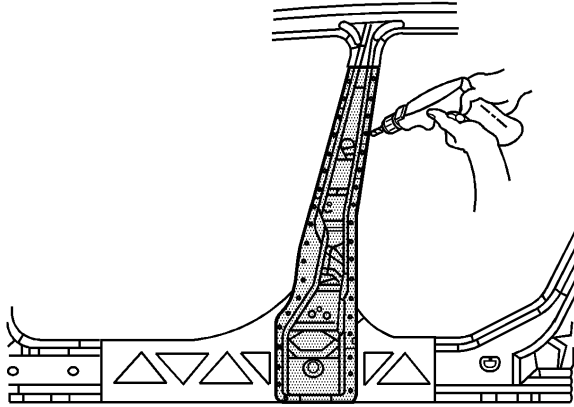
**Important:** Note the number and location of the factory welds for installation of the center pillar.

- Locate, mark, and drill out all the necessary factory welds.

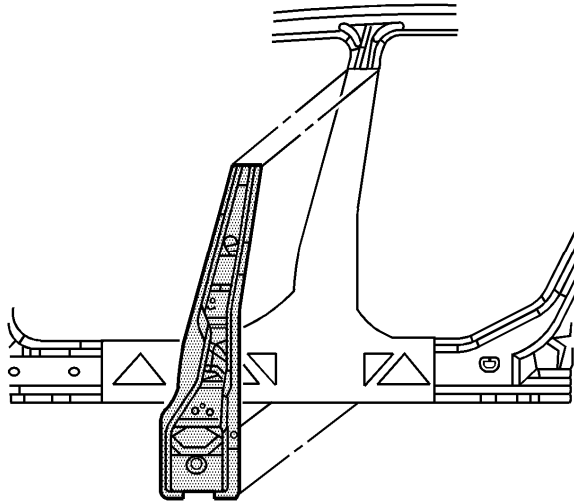
- Remove the damaged front pillar.

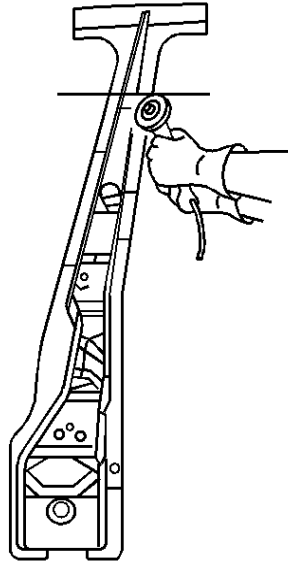
1. Measure the service part 30 mm (1 3/16 in) longer than the original reinforcement to allow for an overlap.
2. Cut the service part at this sectioning location.

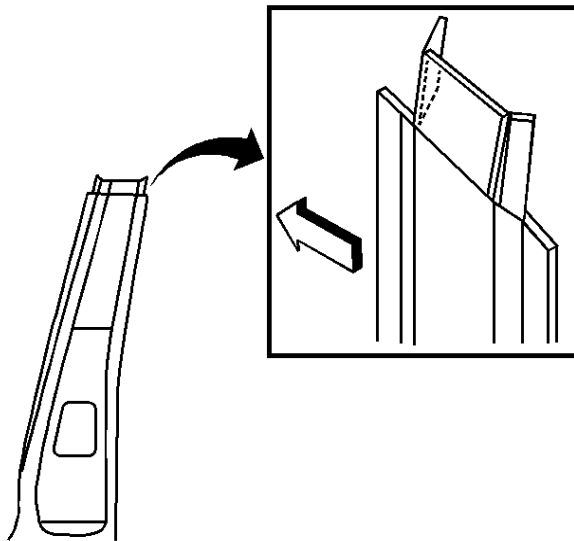
3. Cut the service part in the corners as shown and step the tabs inward to allow the service part to fit under the original reinforcement.

4. Drill 8 mm (5/16 in) plug weld holes along the sectioning cut on the original reinforcement. Locate these holes 13 mm (½ in) from the edge and spaced 40 mm (1½ in) apart.

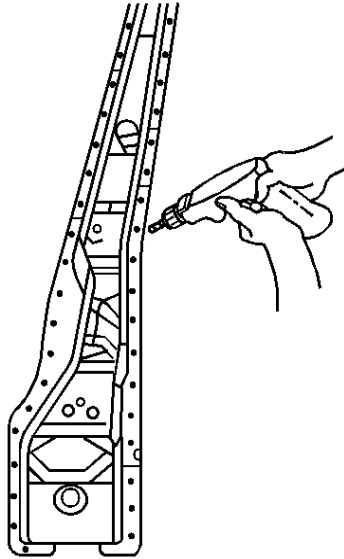
**Important:** If the location of the original plug weld holes can not be determined, or if structural weld-thru adhesive is present, space the plug weld holes every 40 mm (1½ in).

5. Drill 8 mm (5/16 in) plug weld holes in the service reinforcement, as necessary, in the locations noted from the original panel.
6. Prepare all mating surfaces, as necessary.
7. Apply GM-approved Weld-Thru Coating or equivalent to all mating surfaces. Refer to [Anti-Corrosion Treatment and Repair](#) .
8. Apply structural adhesive Lord 108 to locations noted in the removal procedure.

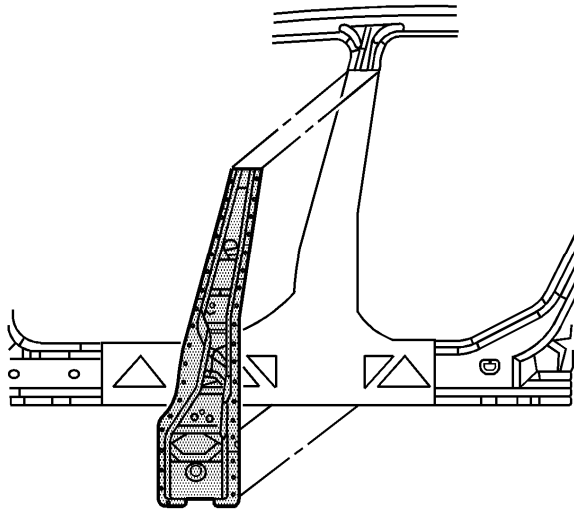
9. Align the service part on the vehicle using 3-dimensional measuring equipment.
10. Plug weld accordingly.
11. To create a solid weld with minimum heat distortion, make 25 mm (1 in) stitch welds along the seam with 25 mm (1 in) gaps between them. Go back and complete the stitch weld.
12. Clean and prepare all of the welded surfaces.
13. Apply the sealers and anti-corrosion materials to the repair area, as necessary.  
Refer to [Anti-Corrosion Treatment and Repair](#) .
14. Paint the repaired area. Refer to [Basecoat/Clearcoat Paint Systems](#) .
15. Install all of the related panels and components.
16. Connect the negative battery cable. Refer to [Battery Negative Cable Disconnection and Connection](#) .
17. Enable the SIR system. Refer to [SIR Disabling and Enabling](#) .
