# Front Inner Hinge Pillar Reinforcement Sectioning

## Removal Procedure

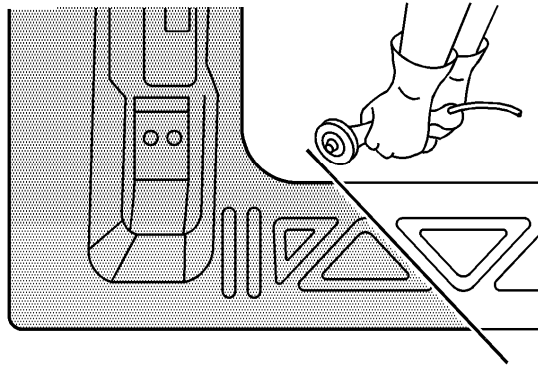
4. Remove the sealers and anti-corrosion materials from the repair area, as necessary. Refer to [Anti-Corrosion Treatment and Repair](#) .
5. Restore as much of the damage as possible.
6. On the windshield pillar, measure down 19 mm ( $\frac{3}{4}$  in) from the base of the windshield pillar reinforcement. This is your section location.

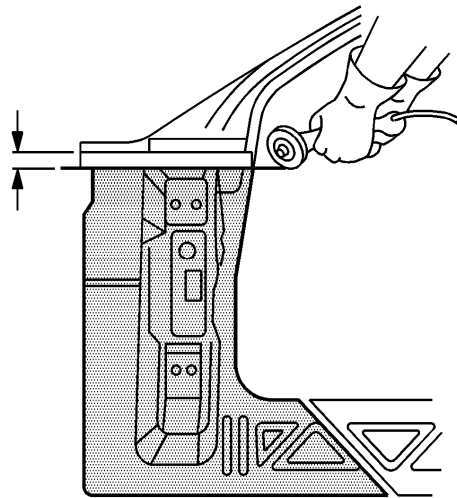
7. On the inner rocker panel, use the second triangular opening as your section location as shown.

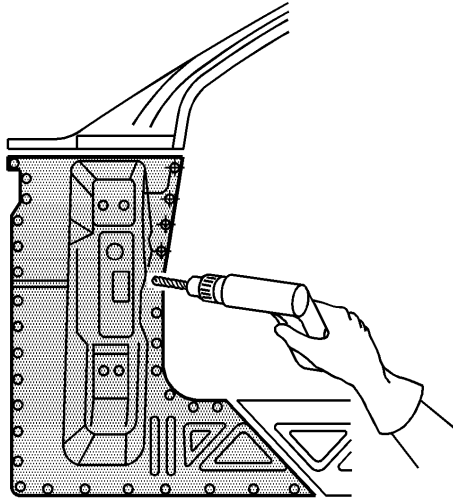
**Important:** Do not damage any inner reinforcements or panels.

- Cut the panel where sectioning is to be performed.

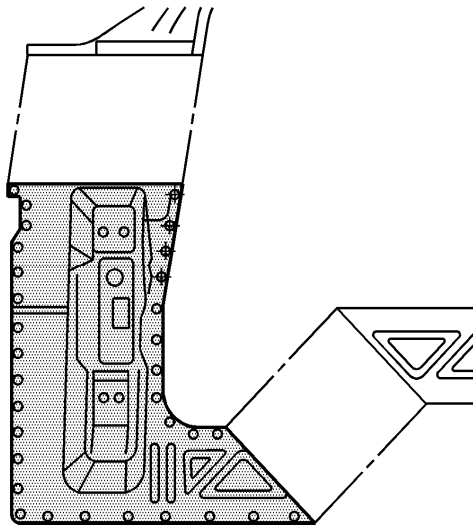
**Important:** Note the number and location of the factory welds for installation of the hinge pillar.

- Locate and drill out all factory welds. Note the number and location of the welds for installation of the service part.

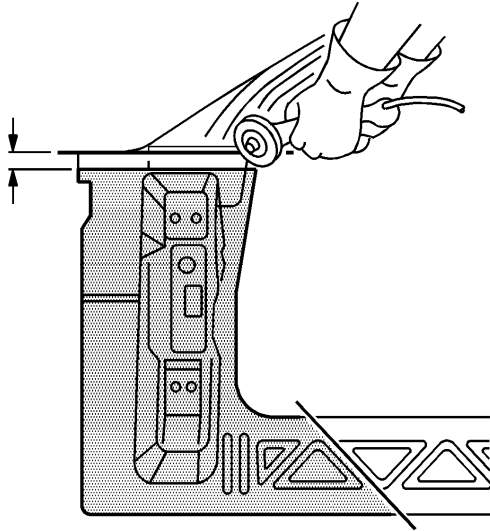
- Remove the damaged inner hinge pillar.

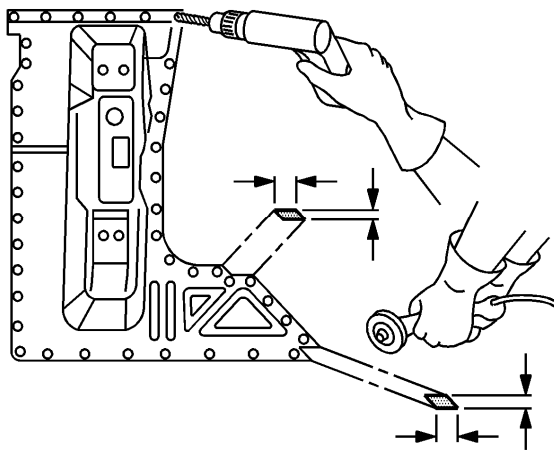
1. Cut the replacement service part horizontally at the bottom edge of the outer windshield pillar reinforcement. In the door opening area, notch the flange for a flush fit as shown.

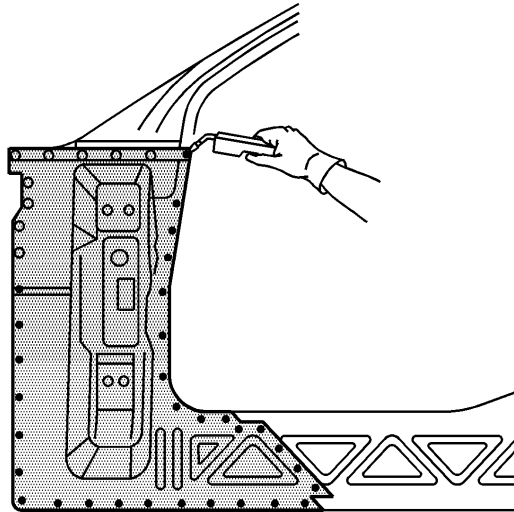
2. Cut the replacement part vertically in the rocker panel area to allow for a full overlap as shown and notch.

**Important:** If the location of the original plug weld holes can not be determined, or if structural weld-thru adhesive is present, space the plug weld holes every 40 mm (1½ in).

3. Drill 8 mm (5/16 in) plug weld holes in the service part as necessary as noted from the original panel.
4. Prepare all mating surfaces as necessary.
5. Apply GM-approved Weld-Thru Coating or equivalent to all mating surfaces. Refer to [Anti-Corrosion Treatment and Repair](#) .
6. Align service part using 3 dimensional measuring equipment. Clamp in place.
