Pillar Sectioning - Center Inner

Removal Procedure

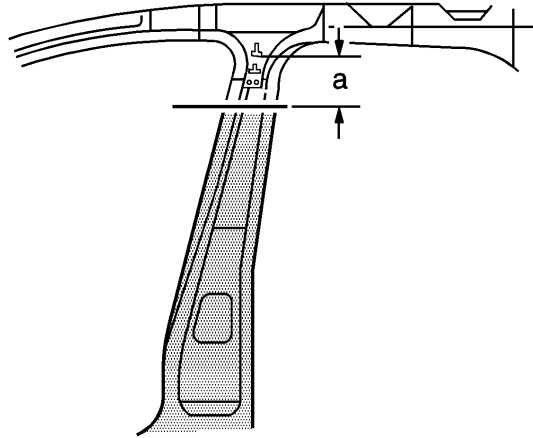
6. Note structural adhesive locations.

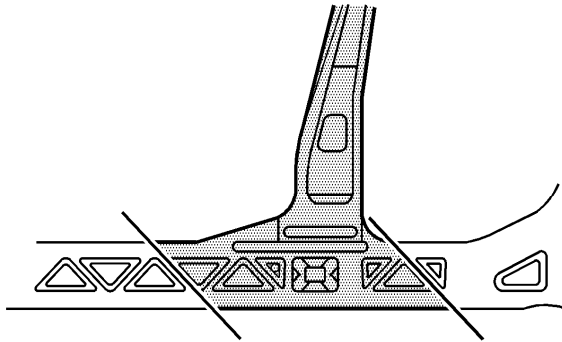
7. In the inner upper center pillar area, locate the "T" shaped opening on the inside of the pillar. Measure down (a) 100 mm (4 in) from the bottom of the opening. This is your sectioning location.

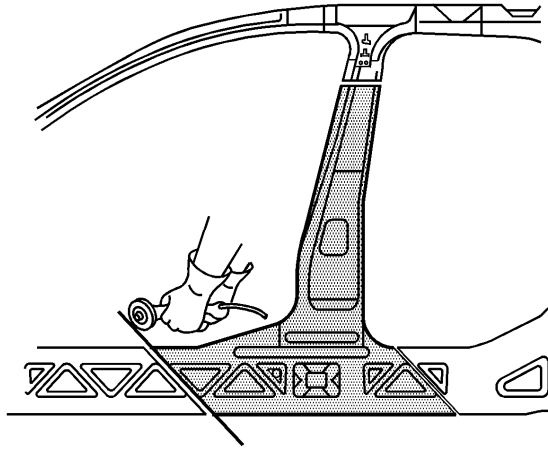
8. In the inner rocker panel area, select the triangle shaped openings in the front and rear of the pillar areas to be replaced as shown. These are your lower section locations.

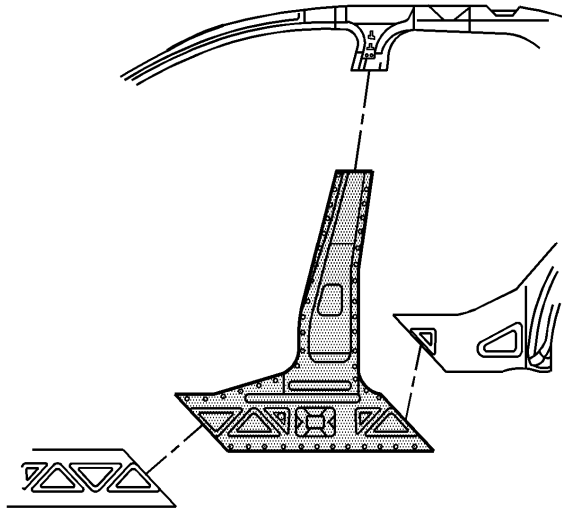
10. Locate and drill out all factory welds. Note the number and location of the welds for installation of the service part.

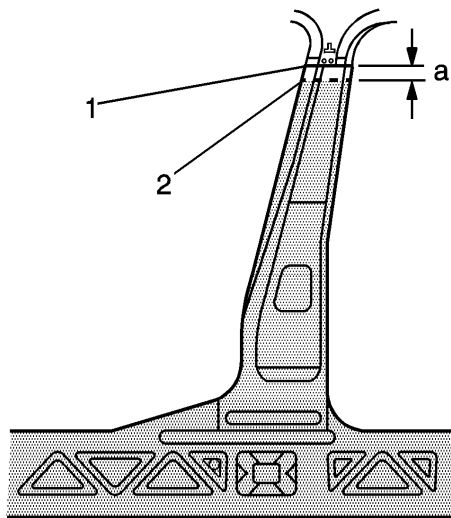
1. Cut the replacement service part in the pillar area (1) to allow for a (a) 25 mm (1 in) overlap of the original section cut.

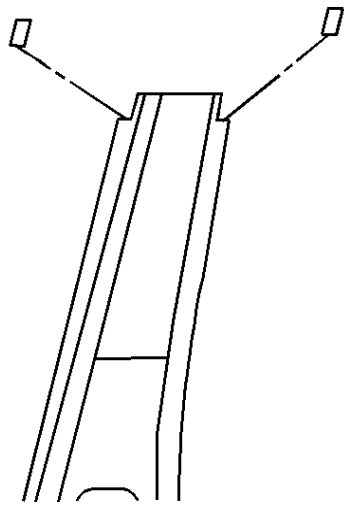
2. On the pillar area of the service part notch the weld flange areas as shown.

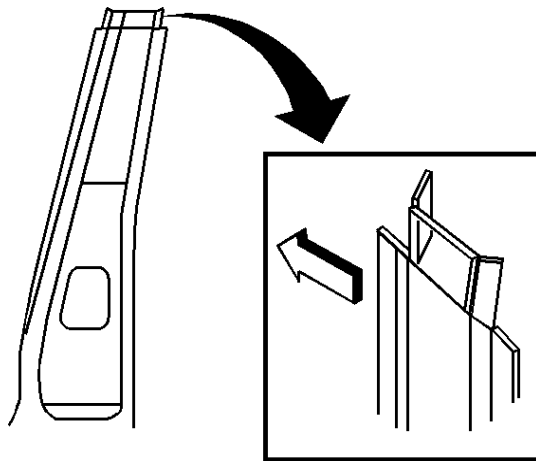
3. Cut the service part in the corners as shown and step the tabs inward to allow the service part to fit under the original reinforcement.
