Rear Compartment Panel Sectioning

Removal Procedure

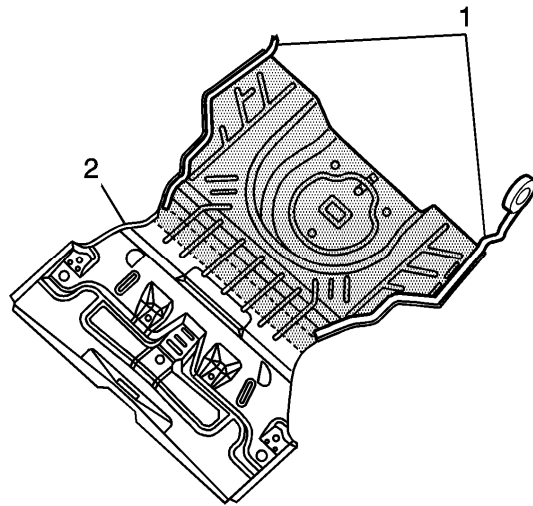
6. Apply a 25 mm (1 in) wide piece of masking tape (1) to the rear compartment panel along the contour of the wheelhouse, from the #5 crossbar to the rear of the compartment panel. Apply the tape on both sides of the rear compartment panel.

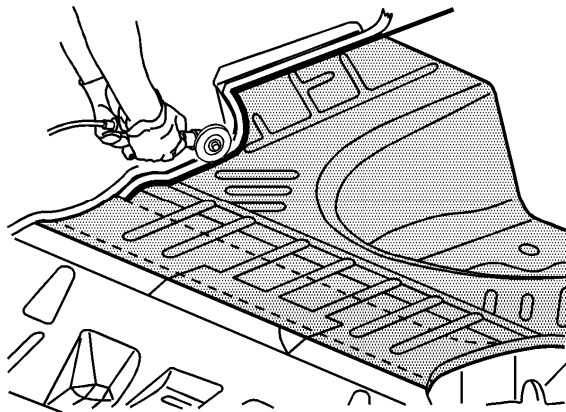
7. Cut along the inboard side of the tape to create a weld flange.

Important: Do not damage any inner panels or reinforcements.

- Cut the rear compartment panel at the rear edge of the #5 crossbar.

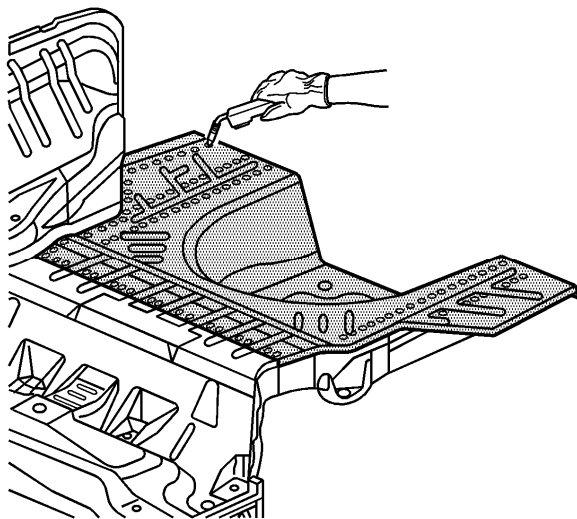
4. Drill 8 mm (5/16 in) plug weld holes in the service part, as necessary, in the locations noted from the original panel.
5. Apply GM-approved Weld-Thru Coating or equivalent to all mating surfaces. Refer to [Anti-Corrosion Treatment and Repair](#) .
6. Install and align the service part using 3-dimensional measuring equipment.

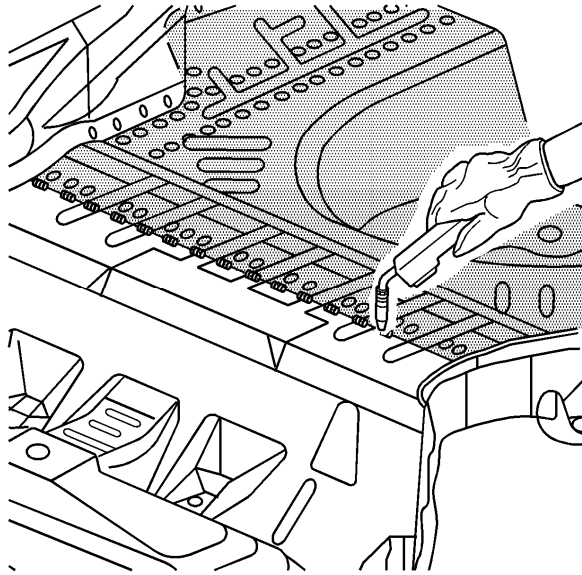
7. Plug weld accordingly.

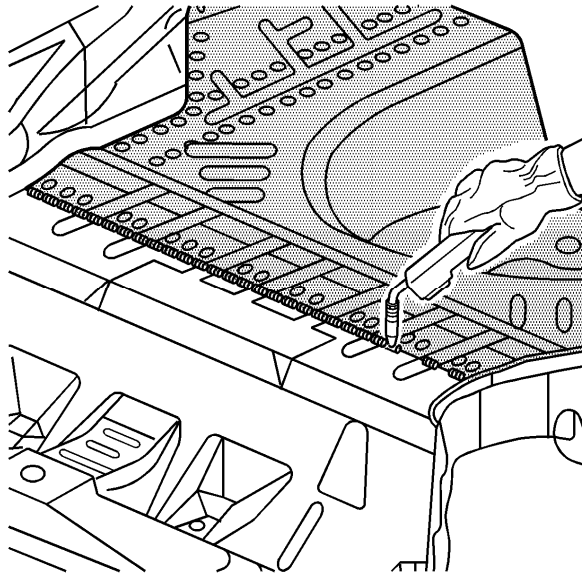
8. To create a solid weld along the front of the service part with a minimum of heat distortion, make a 25 mm (1 in) stitch weld along the seam with 25 mm (1 in) gaps between them.
