Rear Wheelhouse Replacement

Removal Procedure

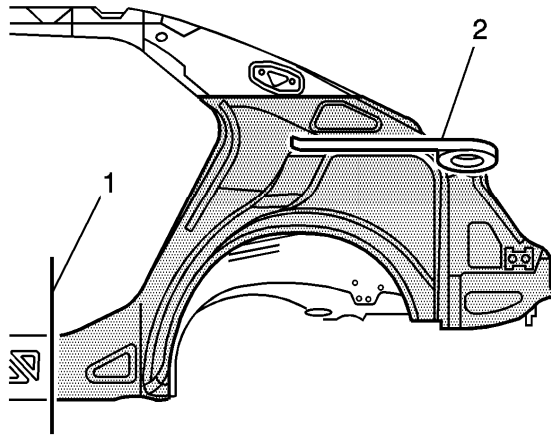
6. Apply a piece of 20 mm (3/4 in) tape (2) along the flat area above the outer wheel housing as shown. This is your sectioning location.
7. In the rocker panel area, mark a vertical line in the flat area rearward of the triangle shaped opening as shown (1). This is your sectioning location.

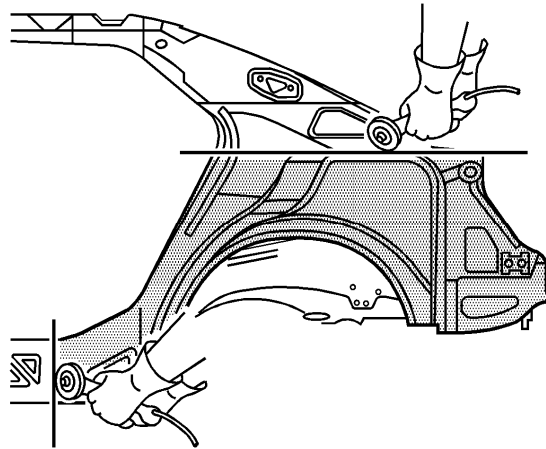
- Cut the panel where sectioning is to be performed.

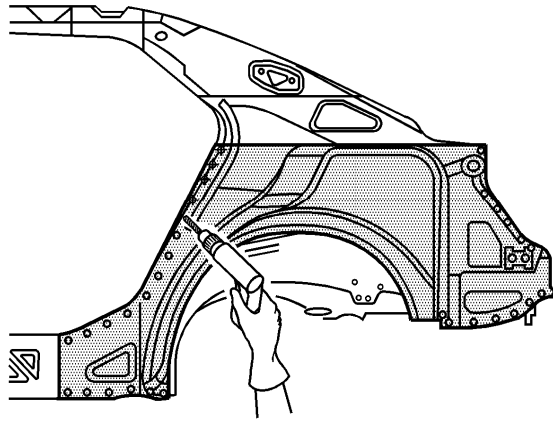
Important: Note the number and location of the factory welds for installation of the quarter panel.

- Locate, mark, and drill out all the necessary factory welds.

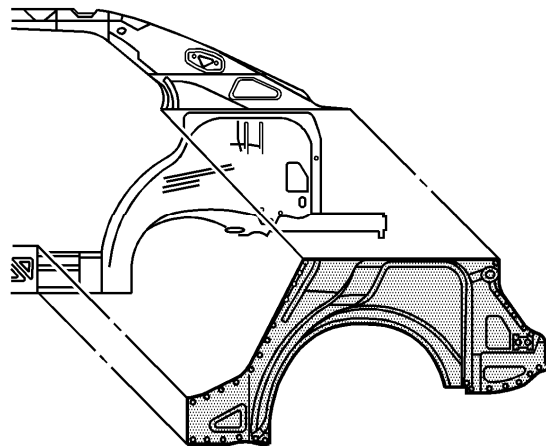
- Remove the damaged wheelhouse section.

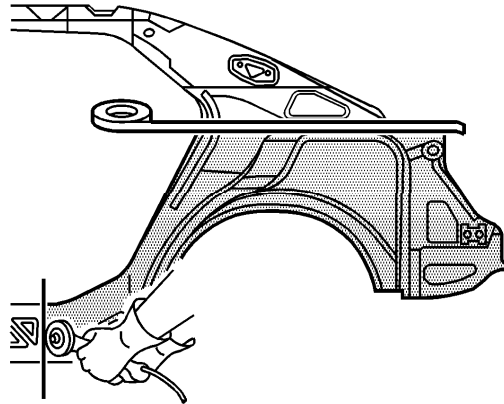
1. Cut the service part in the corresponding locations to the sectioning cuts. Allow for a 25 mm (1 in) overlap to the vehicle.

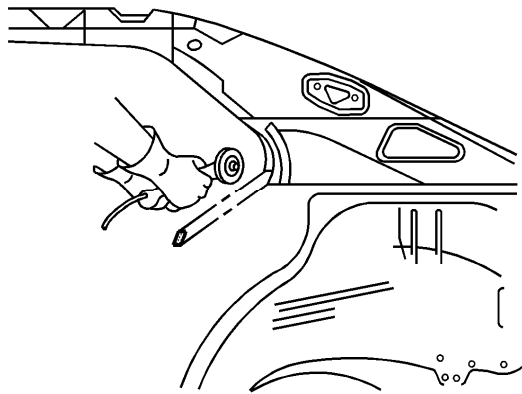
2. In the door opening location notch as shown.

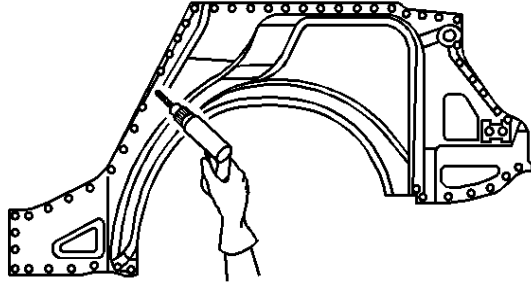
3. Drill 8 mm (5/16 in) plug weld holes along the sectioning cut on the original reinforcement. Locate these holes 13 mm (1/2 in) from the edge and spaced 40 mm (1 1/2 in) apart.

Important: If the location of the original plug weld holes can not be determined, or if structural weld-thru adhesive is present, space the plug weld holes every 40 mm (1 1/2 in).

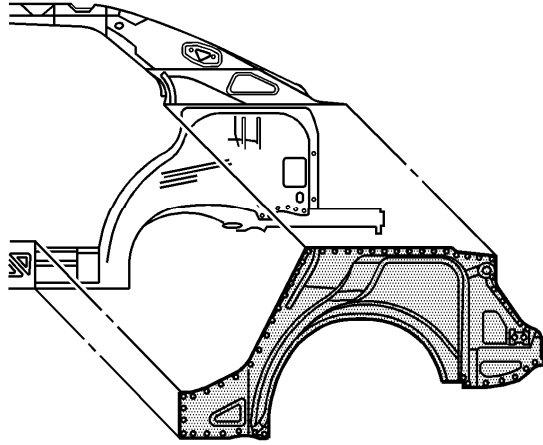
7. Align the service part on the vehicle using 3-dimensional measuring equipment.

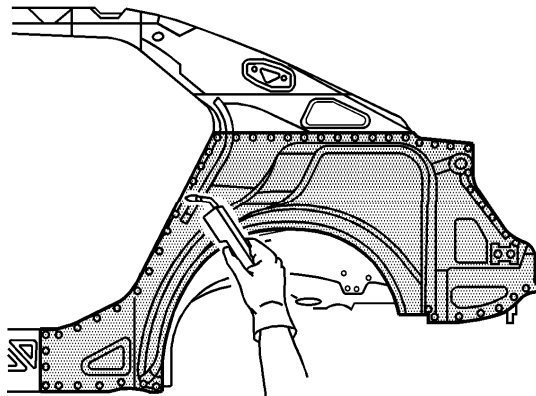
8. Plug weld accordingly.

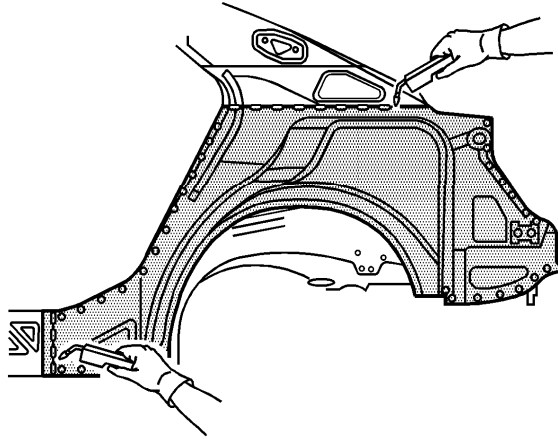
9. To create a solid weld with minimum heat distortion, make 25 mm (1 in) stitch welds along the seam with 25 mm (1 in) gaps between them. Go back and complete the stitch weld.
