Front Compartment Inner Side Rail Sectioning

Removal Procedure

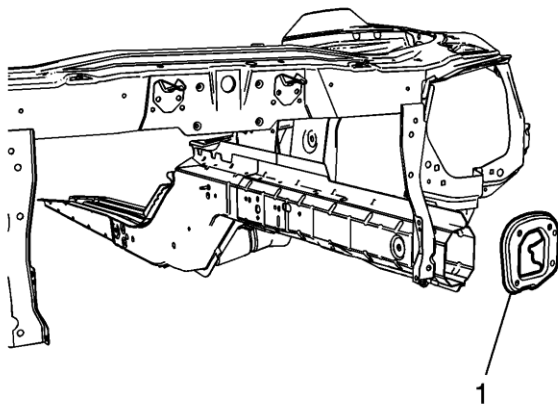
5. Remove Front Bumper Bracket (1).

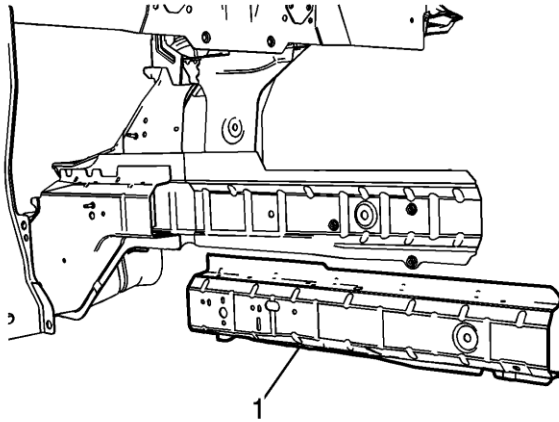
10. Remove the damaged Front Lower Rail (1).

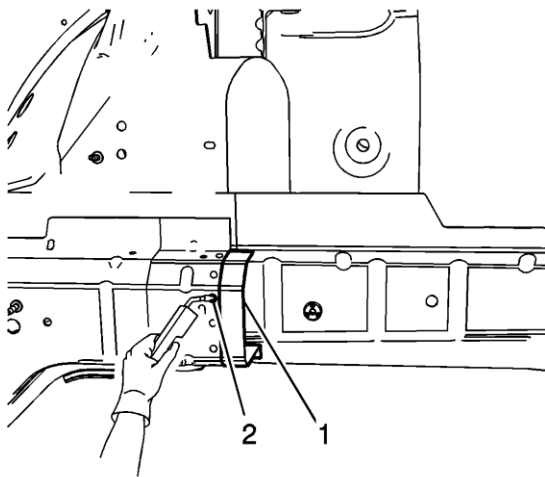
7. Fit the backing plate halfway into the sectioning joint (1), clamp and plug weld to the vehicle (2).
