Underbody Outer Front Side Rail Sectioning

Removal Procedure

Installation Procedure

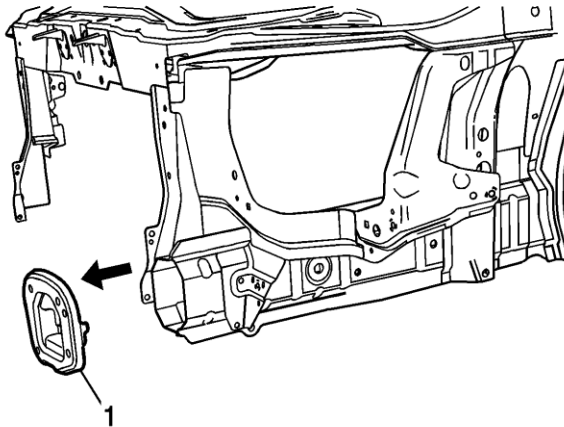
6. Remove the Front bumper Bracket (1).

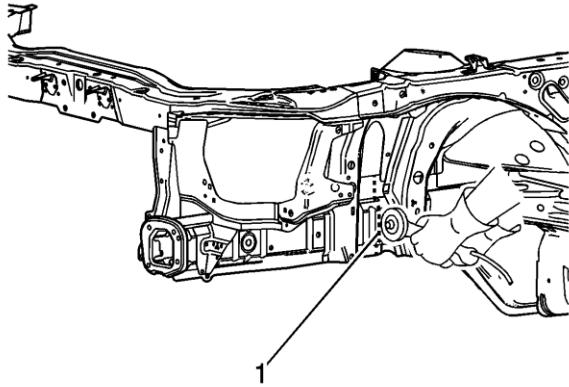
Note: Do not damage any inner panels or reinforcements.

7. Cut the Rail Front Outer Side at the rear edge of the strengthening bead located between the Wheelhouse reinforcements (1).

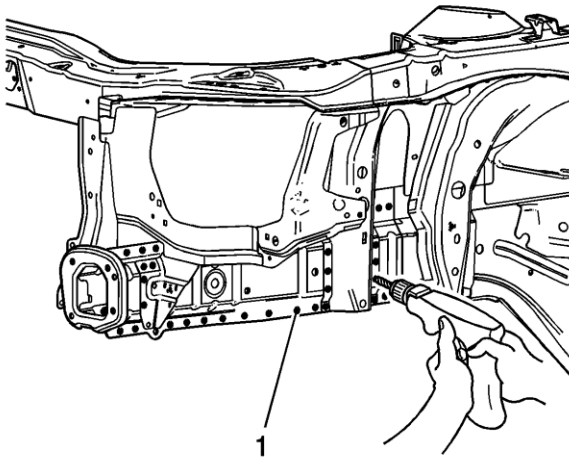
Note: Do not damage any inner panels or reinforcements.

8. Locate and drill out all factory welds. Note the number and note the location of the welds for installation of the service Rail Front Outer Side (1).

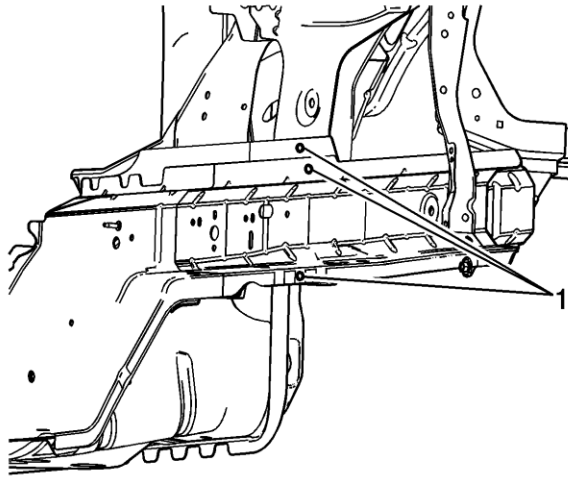
9. Locate and drill out the three hidden welds on the inside flange of the Rail (1). These welds must be drilled all the way through.

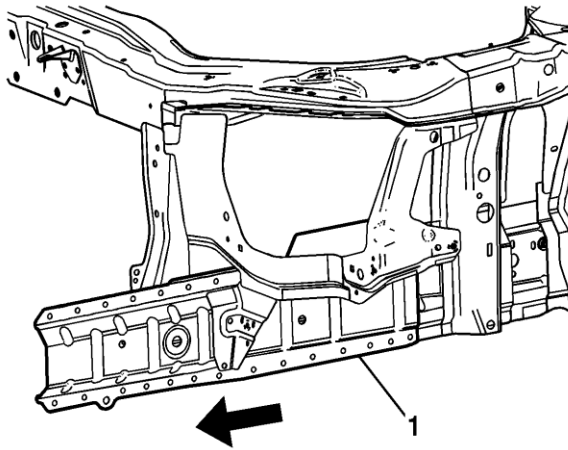
10. Remove the damaged Rail Front Outer Side (1).

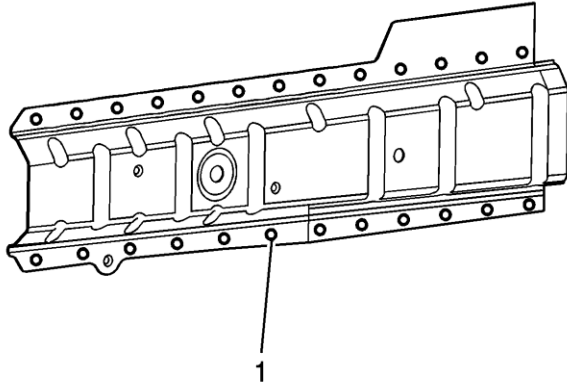
Note: In any area damaged beyond recognition, space plug weld holes every 40 mm (1½ in) apart.

1. Drill 8 mm (5/16 in) plug weld holes in the service part as necessary in the locations noted from the original panel (1).

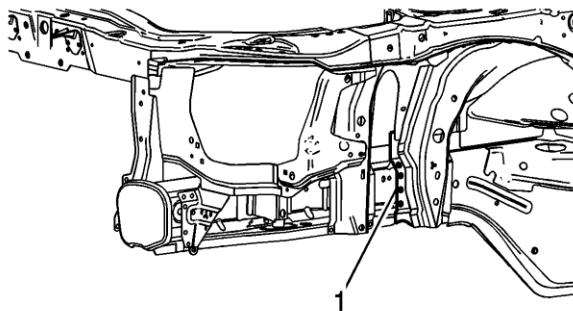
2. Drill 8 mm (5/16 in) plug weld holes along the sectioning cut on the remaining original rail (1). Locate these holes 40 mm (1½ in) apart.
3. Prepare all attachment surfaces as necessary for welding.
4. Apply GM approved Weld-Thru Coating or equivalent to all mating surfaces. Refer to [Anti-Corrosion Treatment and Repair](#).

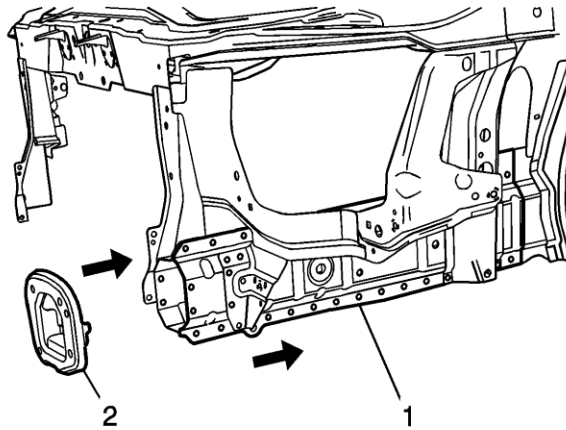
5. Position the service Rail Front Outer Side by sliding the pre-stepped portion of the service rail under the original rail (1).
6. Position the Front Bumper Bracket (2).
7. Clamp service parts in position.
8. Inspect the rail for proper position using 3-dimensional measuring equipment.

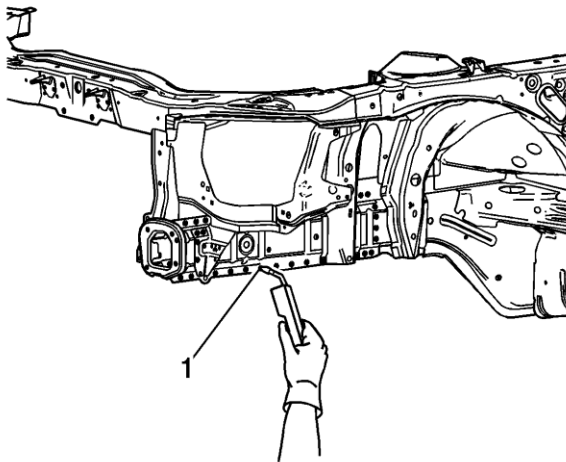
9. Tack weld the parts in position (1).

10. Plug weld accordingly.

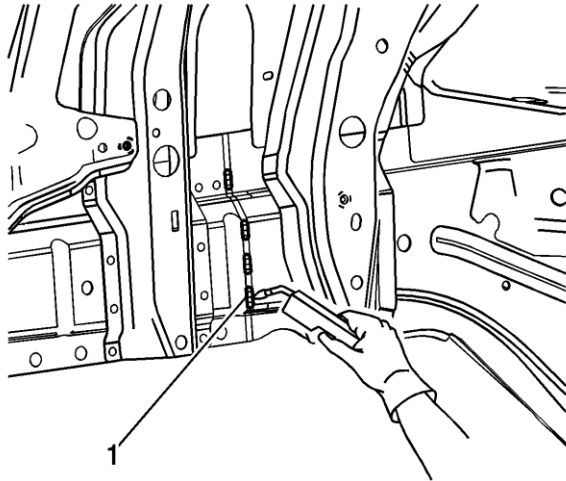
11. Stitch weld along the entire sectioning joint (1), make 25 mm (1 in) welds along the seam with 25 mm (1 in) gaps between.
12. Complete the stitch welds.
13. Clean and prepare all welded surfaces.
14. Apply the sealers and anti-corrosion materials to the repair area, as necessary. Refer to [Anti-Corrosion Treatment and Repair](#).
15. Paint the repair area. Refer to [Basecoat/Clearcoat Paint Systems](#).
16. Install all related panels and components.
17. Connect the negative battery cable. Refer to [Battery Negative Cable Disconnection and Connection](#).
18. Enable the SIR system. Refer to [SIR Disabling and Enabling](#).
