## Door Frame Reinforce Sectioning - Center Pillar

### Removal Procedure

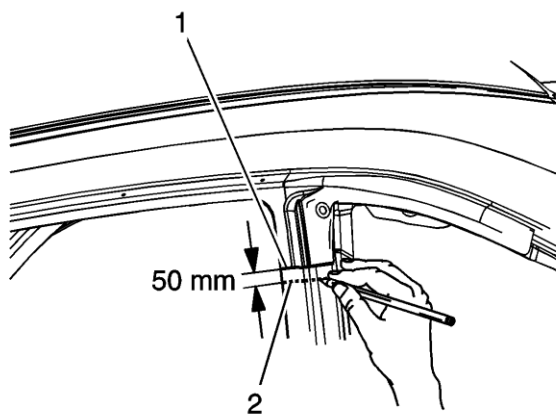
**Note:** Do not damage any inner panels or reinforcements.

7. From the quarter outer panel sectioning cut line (1), measure down 50 mm (2 in) and scribe a line (2).
8. Cut the center pillar where sectioning is to be performed.

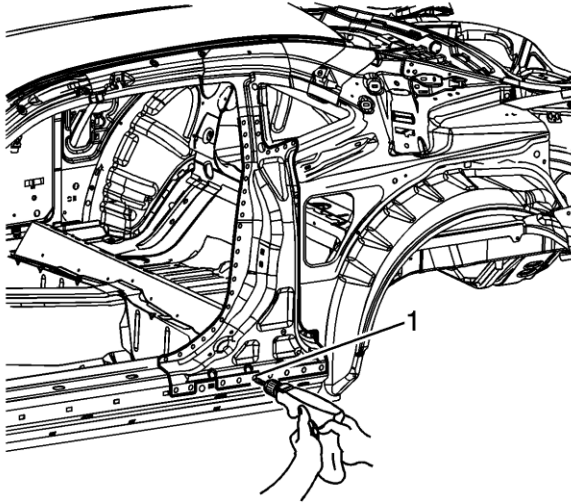
**Note:** Record the number and location of the original welds for installation of the service part.

9. Locate and drill out all factory welds (1).

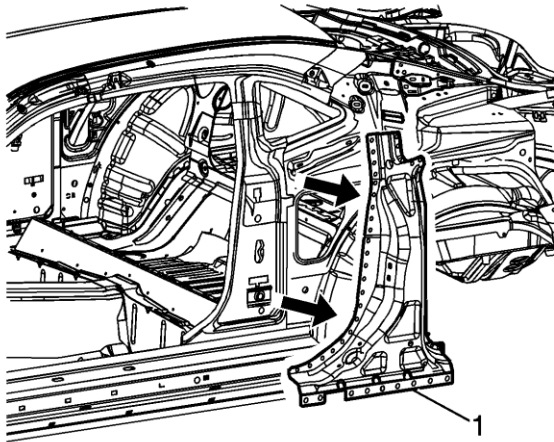
10. Remove the damaged center pillar (1).

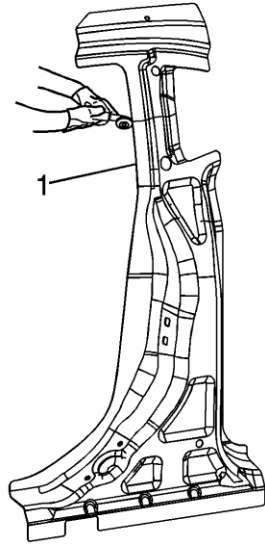
**Note:** The sectioning joint in the center pillar does not require a backing plate the center pillar reinforcement can be used as a weld backer.

1. Cut the replacement center pillar in corresponding locations to fit the original panel (1). The sectioning joint should be trimmed to allow 1.5 times the metal thickness at the sectioning joint.

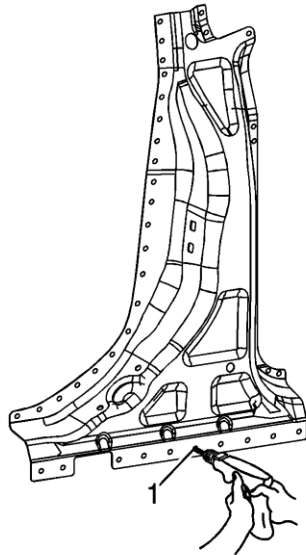
**Note:** In any area damaged beyond recognition, or structural weld thru adhesive was present space plug weld holes every 4 0mm (1 1/2 in) apart.

2. Drill 8 mm (5/16 in) plug weld holes in the service part as necessary in the locations noted from the original panel and along the sectioning cut (1).
3. Prepare all attachment surfaces as necessary.
4. Apply GM approved Weld-Thru Coating or equivalent to all mating surfaces. Refer to [Anti-Corrosion Treatment and Repair](#).

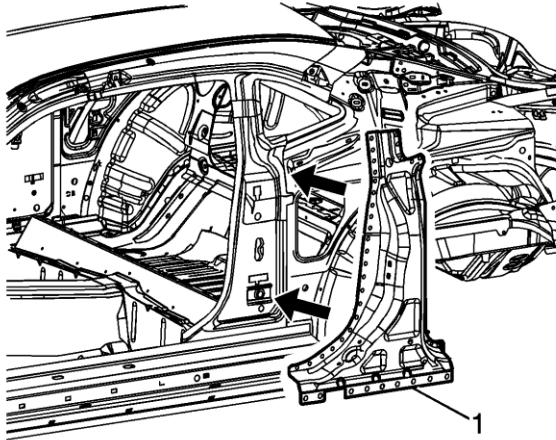
5. Position the service panel to the vehicle (1).
6. Clamp service part in place.
7. Inspect the vehicle for proper dimensions using 3-dimensional measuring equipment.

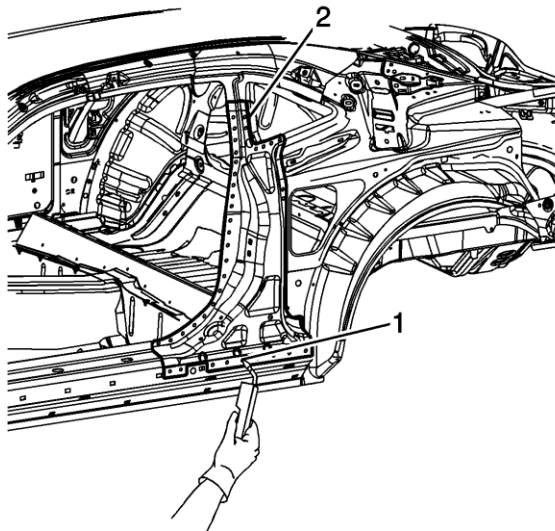
8. Plug weld accordingly (1).

**Note:** To create a solid weld with minimum heat distortion make 25 mm (1 in) stitch welds along the seam with 25 mm (1 in) gaps between them. Then go back and complete the stitch weld

9. Stitch weld sectioning joint (2).
10. Clean and prepare all welded surfaces.
11. Apply the sealers and anti-corrosion materials to the repair area, as necessary. Refer to [Anti-Corrosion Treatment and Repair](#).
12. Paint the repair area. Refer to [Basecoat/Clearcoat Paint Systems](#).
13. Install all related panels and components.
14. Connect the negative battery cable. Refer to [Battery Negative Cable Disconnection and Connection](#).
15. Enable the SIR system. Refer to [SIR Disabling and Enabling](#).
