Front Compartment Upper Side Rail Sectioning

Removal Procedure

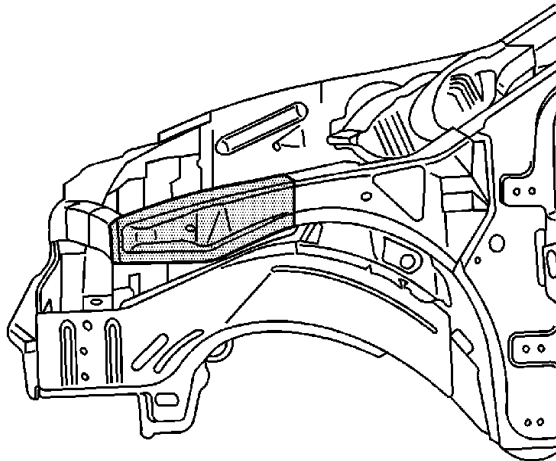
Important: Note the number and location of the factory welds for installation of the front compartment upper side rail.

6. Locate and drill out all the necessary factory welds.

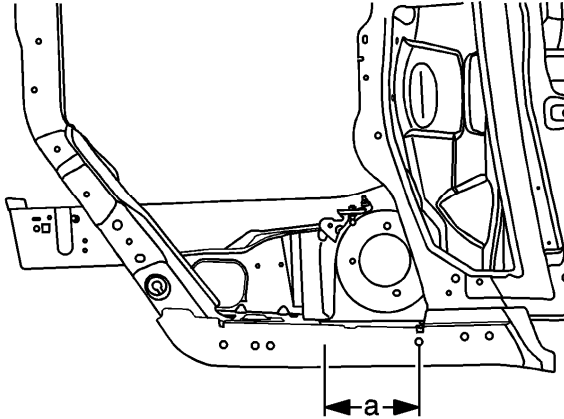
7. Measure forward 225 mm (8 7/8 in) (a) of the center of the forward hood hinge attachment bolt hole location. Mark the location.
8. Using the mark made in the previous step as a starting point, use a sliding square to transfer a line on the top, side, and bottom of the rail.

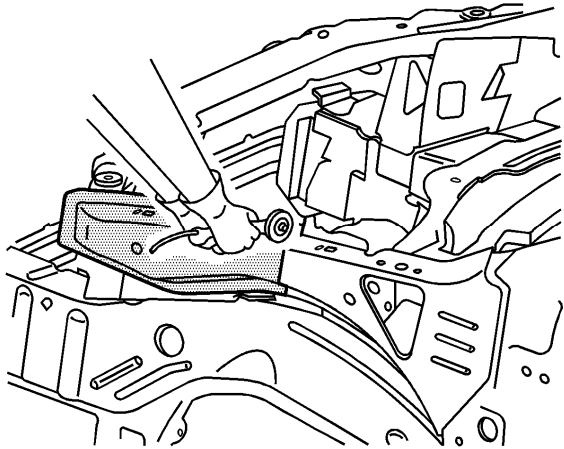
9. Cut the side upper rail at the marked location.

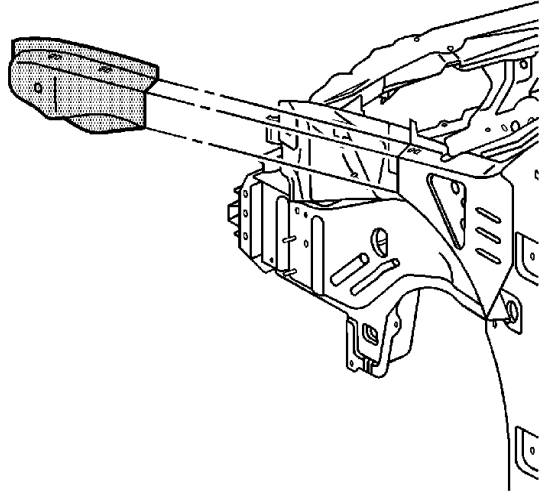
10. Remove the front portion of the side upper rail.
11. Drill two 8-mm (5/16-in) plug weld holes 10 mm (1/2 in) rearward from the edge of the top, bottom, and outer side on the front edge of the remaining portion of the side upper rail on the vehicle.

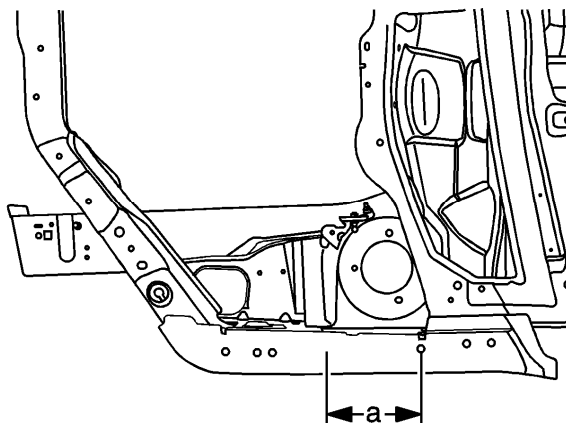
1. Measure on the service part 200 mm (7 7/8 in) (a) forward of the hood hinge attachment bolt hole location. Mark the section.
2. Using the mark made in the previous step as a starting point, use a sliding square to transfer a line on the top, side, and bottom of the rail.

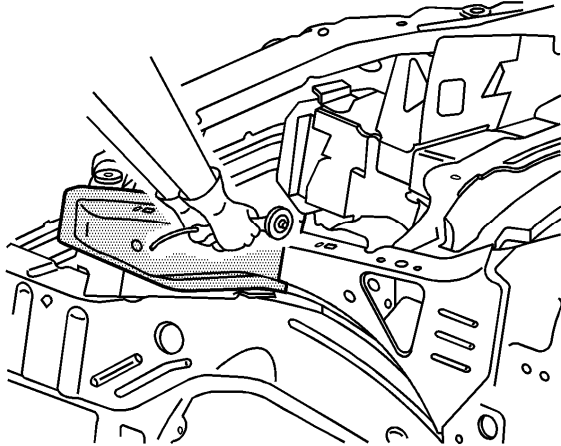
3. Cut the service part at the marked location.

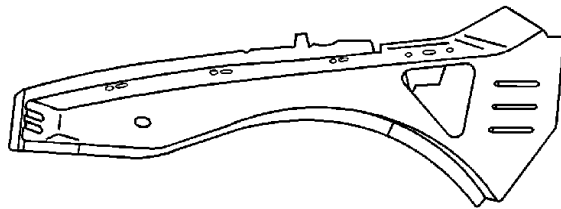
Important: If the location of the original plug weld holes can not be determined, space the plug weld holes every 40 mm (1½ in) apart.

4. Drill 8 mm (5/16 in) plug weld holes as necessary in the locations noted on the original panel.
5. Prepare all mating surfaces as necessary.

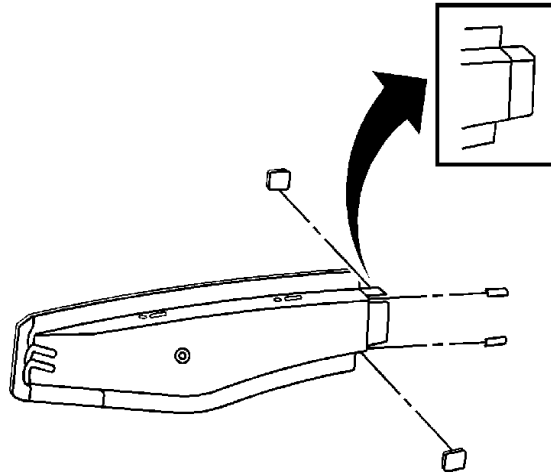
Important: Do not cut past the scribed line.

9. At the weld flange areas of the rail and at each radius, cut toward the scribed line. This will aid in the flange-forming process.
10. Bend the cut area of the rail inward to create a 25 mm (1 in) step flange for the weld joint.

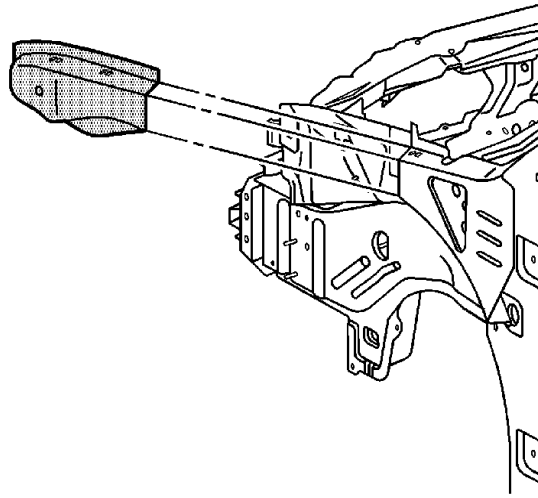
Important: Flanges on the service part will slide inside the rail portion of the vehicle.

11. Position the side upper rail to the vehicle using 3-dimensional measuring equipment. Clamp the rail in place.

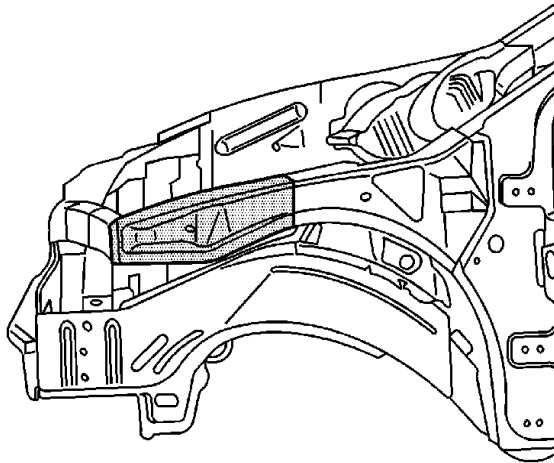
12. Stitch and plug weld accordingly.
13. Clean and prepare all of the welded surfaces.
14. Install all of the related panels and components.
15. Apply the sealers and anti-corrosion materials to the repair area, as necessary.
Refer to [Anti-Corrosion Treatment and Repair](#) in Paint and Coatings.
