# Lower Rail Sectioning

## Removal Procedure

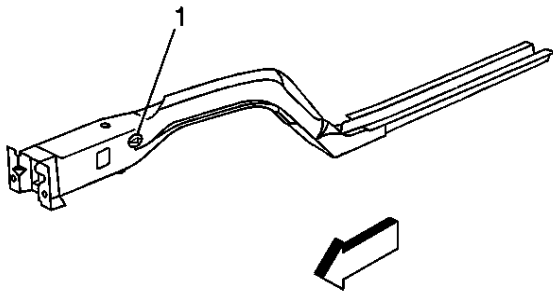
**Important:** Sectioning procedures have been developed to simplify repair of the lower rails, providing the majority of the damage can be returned to factory specifications. This allows the damaged front section to be replaced without performing a full rail replacement. The rails are manufactured with diemarks (1) inboard and outboard to indicate the location for the sectioning joint.

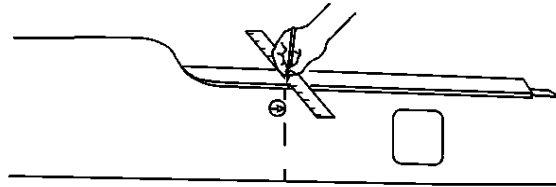
4. Remove all panels and components necessary for access, including the strut and axle assemblies.
5. Remove sealers and anti-corrosion materials as necessary.
6. Locate the diemarks in the rail.

7. Use a straight edge to scribe lines around the rail.

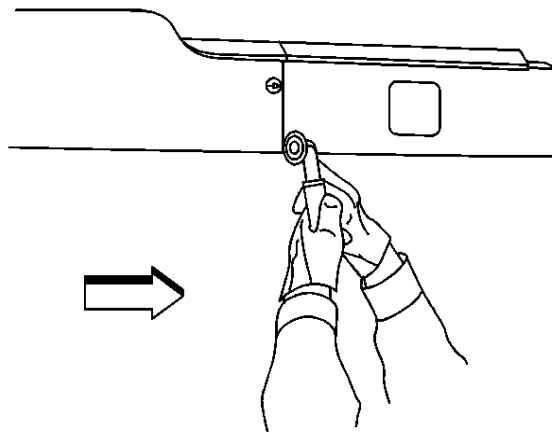
8. Mark and cut the damaged rail at the diemarks.
9. Remove the damaged section of the rail.

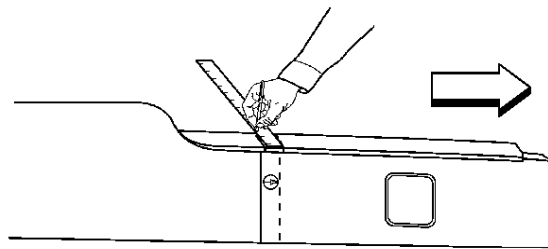
1. Measure from the diemarks to add 20 mm (3/4 in) in length to the service part.
2. Align marks with a straight edge and scribe line for sectioning cut.
3. Cut the service part along the marked lines.
4. Leave 20 mm (3/4 in) added lengths to the service part for sectioning overlap.
5. Cut and remove approximately 20 mm (3/4 in) of the outboard and downward turned flanges of the service part.

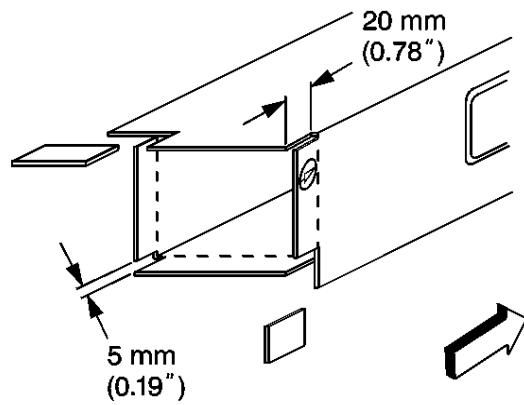
6. Cut 5 mm (3/16 in) wide and 20 mm (3/4 in) long slots along the corners of the service part to create tabs on the four sides of the rail.

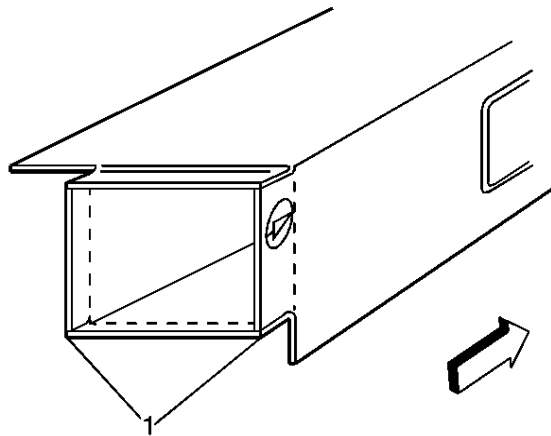
7. Step the top, bottom and side tabs inward to allow the service part to fit inside the original rail.
8. Apply GM-approved Weld-Thru Coating or equivalent to all mating surfaces. Refer to [Anti-Corrosion Treatment and Repair](#).

9. Welds the tabs (1) together along the corners of the service part.

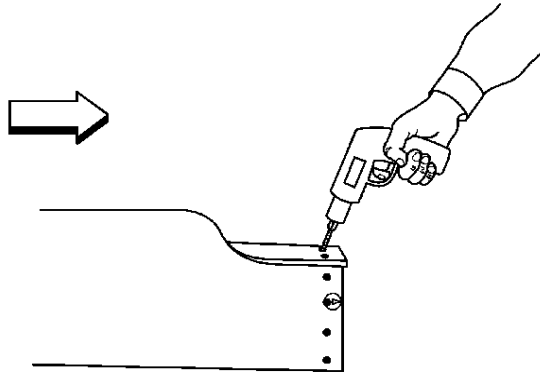
10. Drill 8 mm (5/16 in) plug weld holes in the top, bottom and sides of the original approximately 10 mm (3/8 in) from the sectioning cut.
11. Clean and prepare the mating surfaces as necessary.
12. Position the stepped tabs of the modified service part inside the original rail.  
Allow 20 mm (3/4 in) of overlap.
13. Align and check fit using three dimensional measuring equipment.
14. Plug weld accordingly.
15. Check measurements frequently to ensure proper fit and alignment.
16. Stitch weld along the entire sectioning joint.

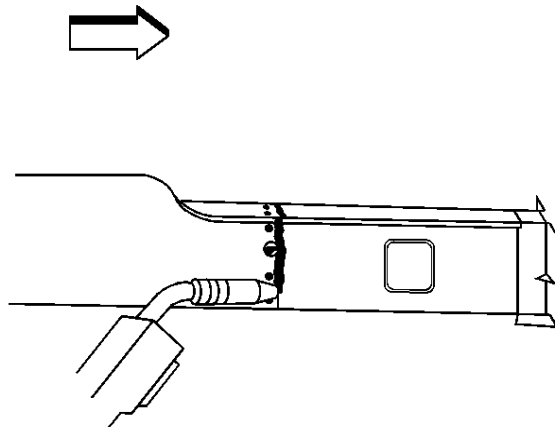
17. Make 25 mm (1 in) welds along the seam with 25 mm (1 in) gaps between them.

18. Go back and complete the stitch weld. This will create a solid joint with minimal heat distortion.
19. Clean and prepare welded surfaces.
