Pillar Lock Front Door Reinforcement Replacement - Outer

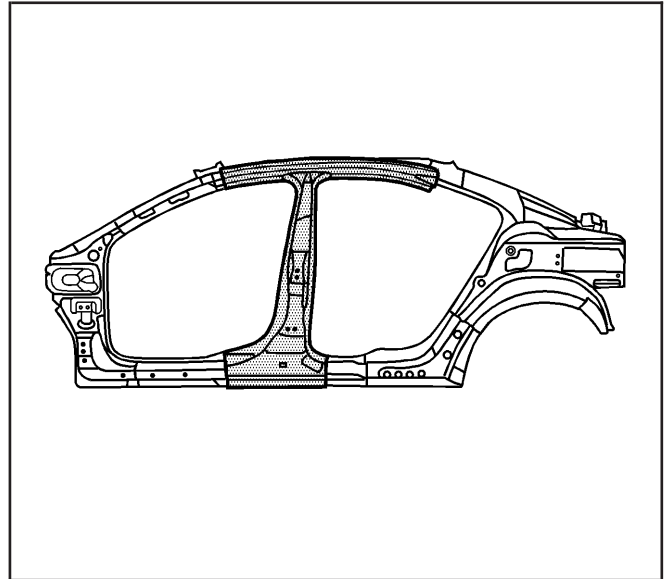
1470544

6. Locate and drill out all the necessary factory welds.
7. Remove the damaged front pillar.

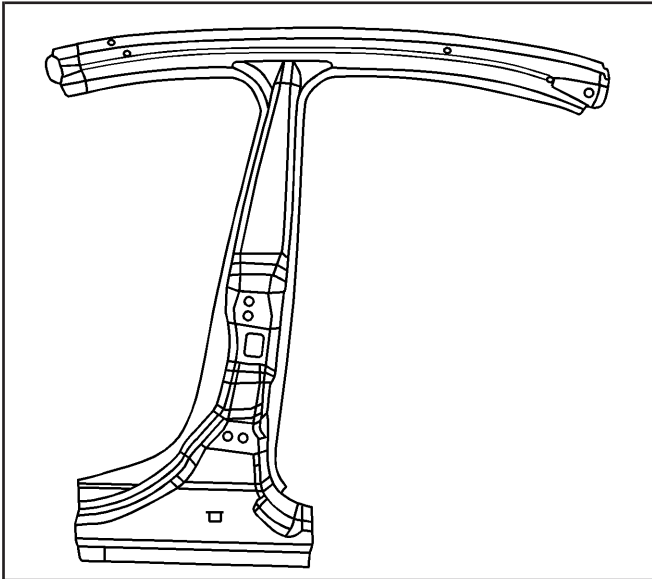
1470378

1. Drill 8 mm (5/16 in) plug weld holes in the service reinforcement as necessary in the corresponding locations noted on the original panel.
2. Prepare all mating surfaces for welding as necessary.
3. Apply 3M® Weld-Thru Coating P/N 05916 or equivalent to all mating surfaces.

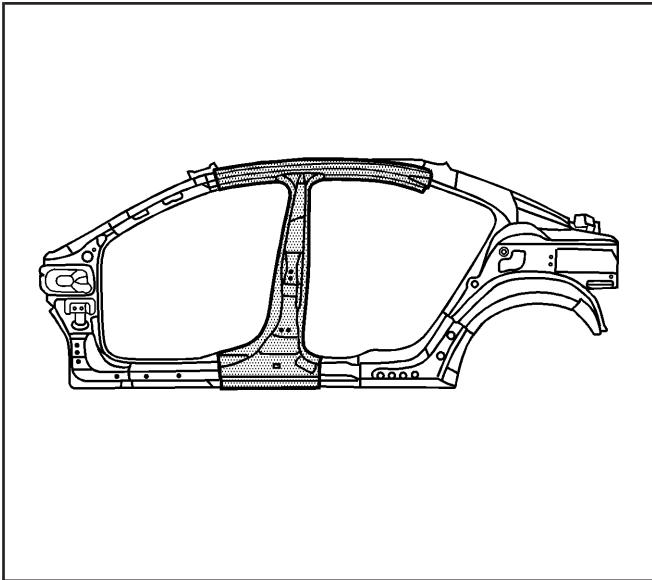
1470544

4. Position the service part on the vehicle using 3-dimensional measuring equipment. Clamp the part in place.
5. Plug weld accordingly.
6. Clean and prepare all of the welded surfaces.
7. Apply the sealers and anti-corrosion materials to the repair area, as necessary. Refer to *Anti-Corrosion Treatment and Repair*.
8. Paint the repaired area. Refer to *Basecoat/Clearcoat Paint Systems*.
9. Install all of the related panels and components.
