## Quarter Panel Replacement - Inner

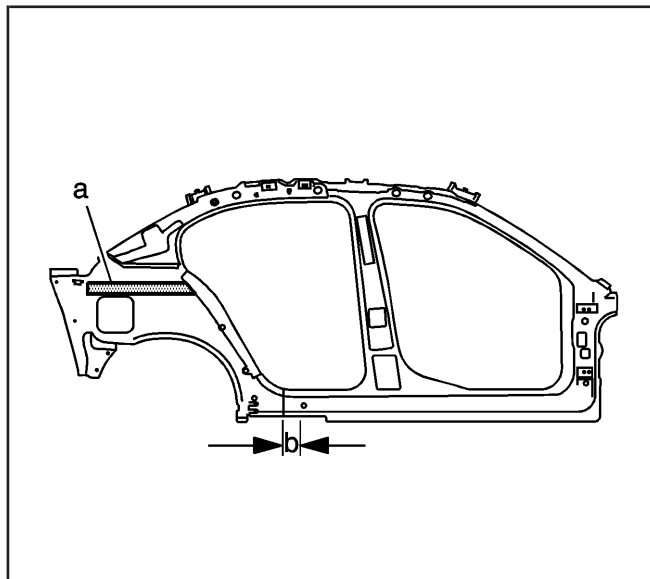
1367141

7. Apply a piece of 50 mm (2 in) tape (a) along the flat area above the outer wheel housing, just below the package shelf mating surface, as shown. This is your sectioning location.
8. In the rocker panel area, measure 40 mm (1.5 in) rearward from the rear 25 mm locating hole as shown (b). Scribe a line. This is your sectioning location.

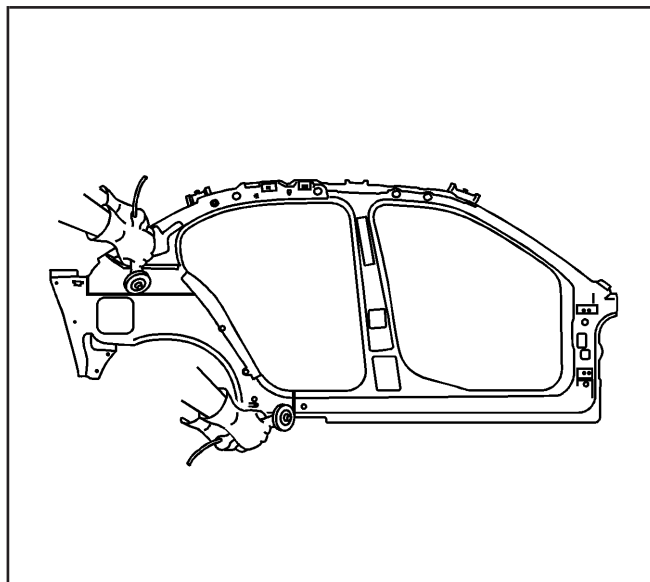
1367145

9. Cut the panel to be sectioned.

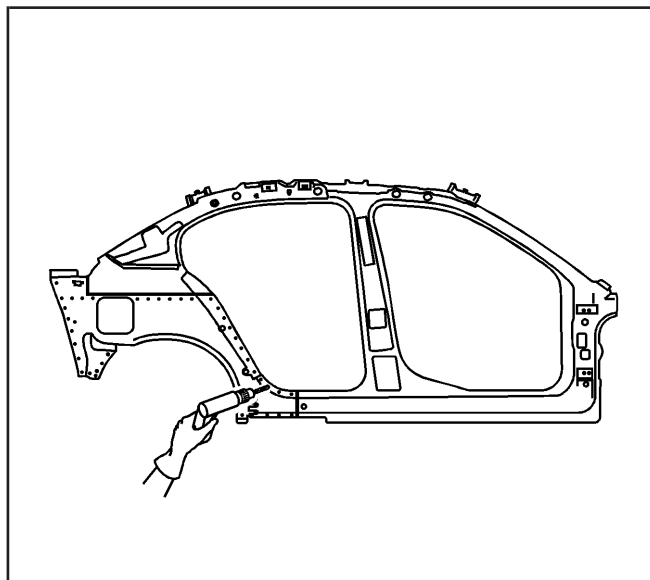
1208075

10. Locate, mark, and drill out all the necessary factory welds.

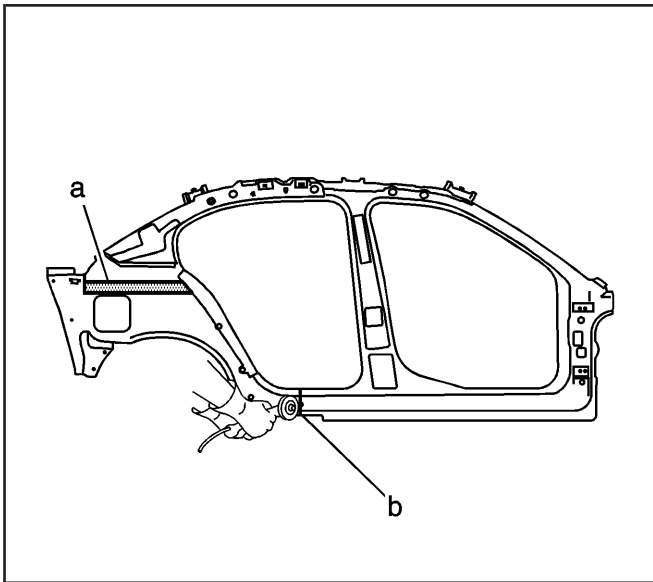
1367147

11. Remove the damaged wheelhouse section.

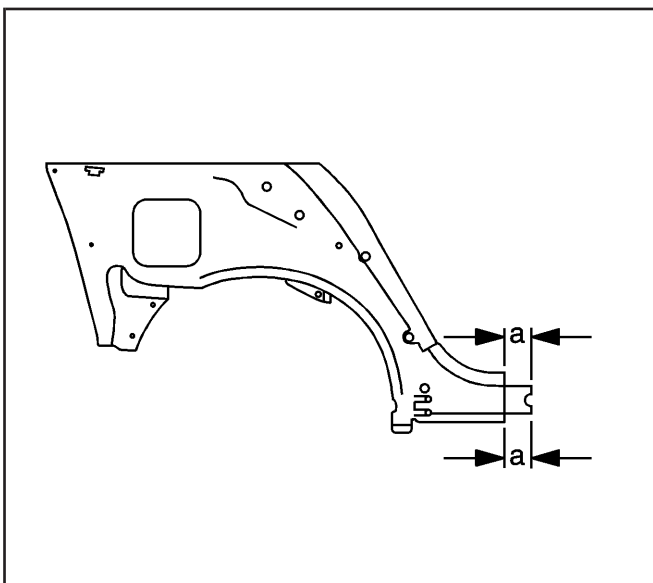
1367151

1. Cut the service part in the corresponding locations to the sectioning cuts. Allow for a 50 mm (2 in) overlap at the wheelhouse.
2. Apply 50 mm (2 in) masking tape above the flat area of the wheel house. Cut on the top edge of the masking tape (a) to correspond with the mating surface of the package shelf extension.
3. Scribe a line. Cut the panel (b) in a straight vertical line through the 25 mm locating hole.

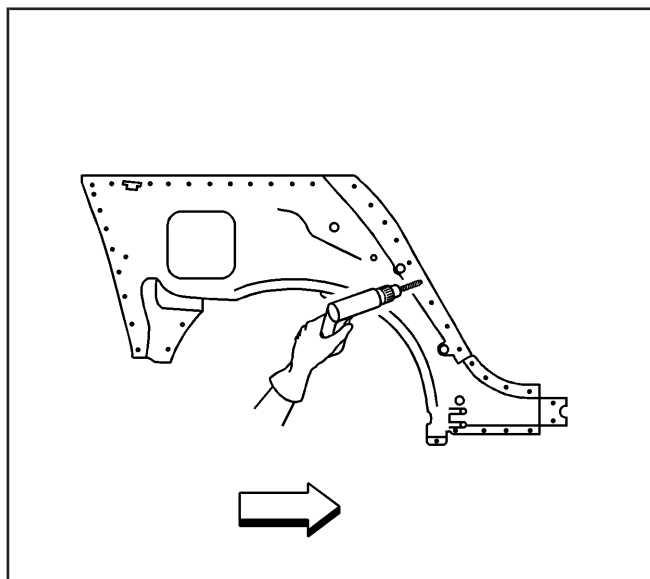
1367157

4. At the cut edge of the service rocker panel, measure rearward 50 mm (2 in) (a). Notch out the rocker panel flange to allow the underlap to the extension rocker.

5. Drill 8 mm (5/16 in) plug weld holes along the sectioning cut on the original reinforcement. Locate these holes 25 mm (1 in) from the edge and spaced 40 mm (1½ in) apart.

6. Drill 8 mm (5/16 in) plug weld holes in the service reinforcement as necessary in the locations noted from the original panel.
7. Prepare all mating surfaces as necessary.
8. Apply 3M Weld-Thru Coating P/N 05913 or equivalent to all mating surfaces.

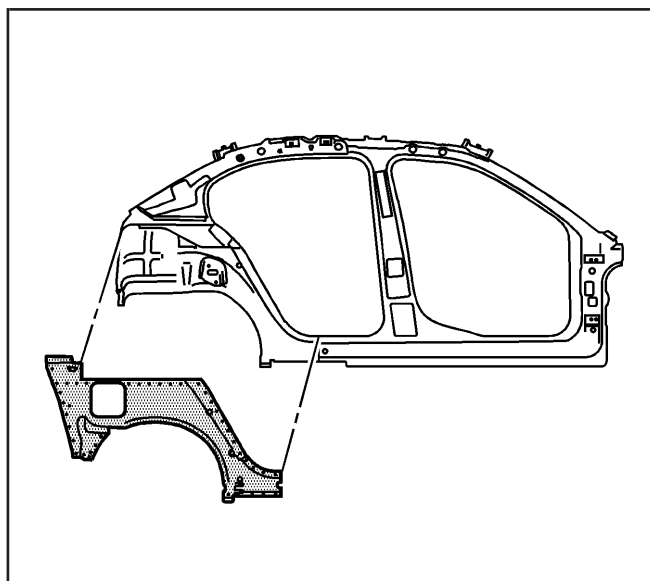
1367195

9. Align the service part on the vehicle using 3-dimensional measuring equipment.

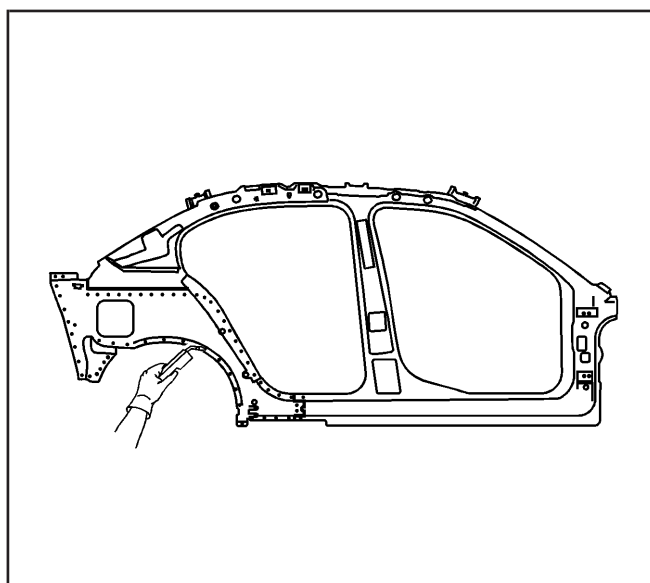
1367202

10. Plug weld accordingly.

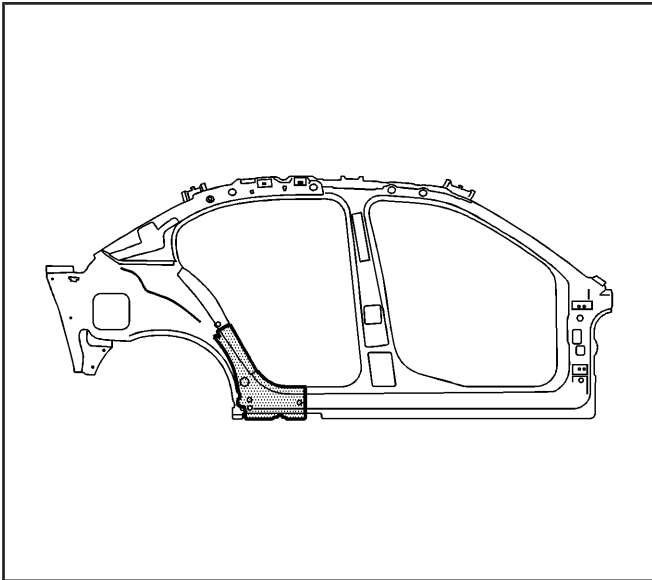
1208057

11. To create a solid weld with minimum heat distortion, make 25 mm (1 in) stitch welds along the seam with 25 mm (1 in) gaps between them. Go back and complete the stitch weld.

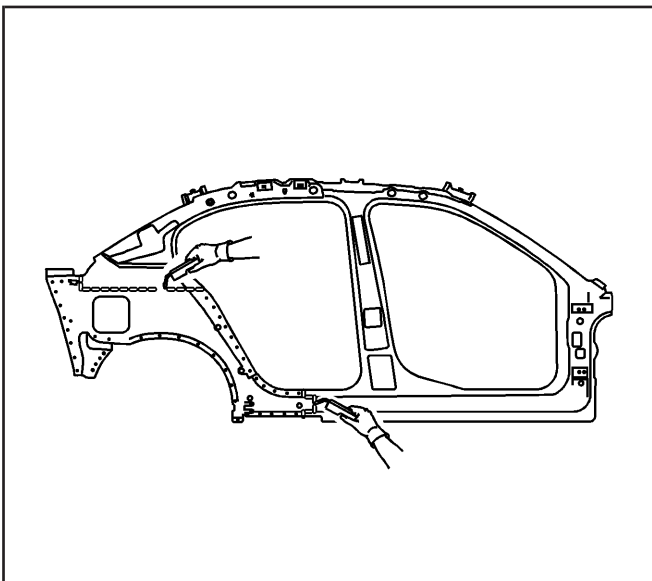
1208260

12. Install the body inner reinforcement.
