Front Hinge Pillar Sectioning

Removal Procedure

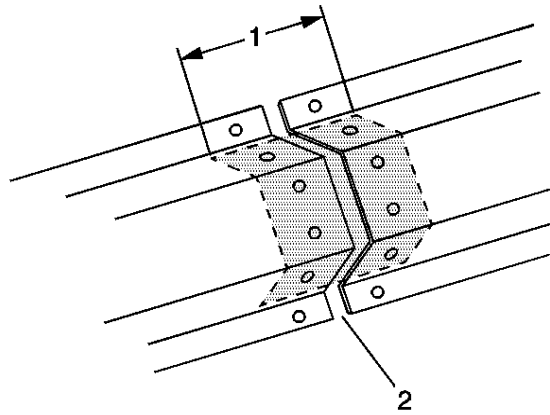
Important: Sectioning the outer rocker panel requires a 100 mm (4 in) backing plate for reinforcement (1). Do not perform sectioning on key structural areas on the outer rocker panel. Sectioning in these areas may compromise the structural integrity of the vehicle.

1. Sectioning of the inner reinforcement panel can only take place with the outer door frame replacement or sectioning procedures. Section of the outer door frame at the front hinge pillar requires a 40 mm (1 9/16 in) offset from the inner reinforcement sectioning joint. The inner reinforcement can serve as a backing plate for the outer panel sectioning.
2. Disable the SIR system. Refer to [SIR Disabling and Enabling](#) in SIR.
3. Disconnect the negative battery cable. Refer to [Battery Negative Cable Disconnection and Connection](#) in Engine Electrical.

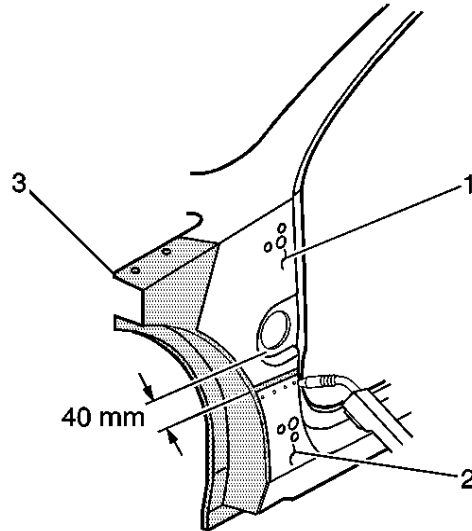
8. On the original outer door frame (1) measure down from the large wiring harness hole in the pillar 40 mm (1 9/16 in) and mark a horizontal line.
9. Cut the outer door frame along this line for sectioning.
10. Perform additional sectioning procedures as necessary to remove damaged areas of the door frame opening.
11. Locate, mark, and drill out all necessary factory welds. Note the number of the welds for installation of the service panel (2).
12. Remove the damaged section of the door frame opening.

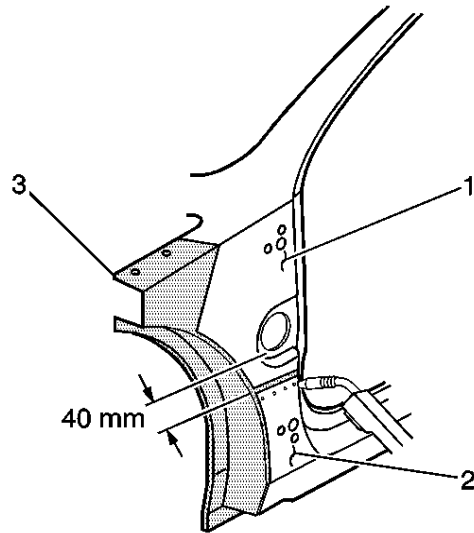
4. Drill holes for plug welding along the sectioning cut on the service part (2).
5. Locate these holes approximately 13 mm (½ in) from the edge of the sectioning cut.

6. Use the inner reinforcement (3) as a backing plate.
7. Apply GM-approved Weld-Thru Coating or equivalent to all mating surfaces. Refer to [Anti-Corrosion Treatment and Repair](#) .

8. Stitch weld along the entire joint (3).
9. Make 25 mm (1 in) gaps between.
10. Go back and complete the stitch weld. This will create a solid joint with minimal heat distortion.

1. On the service part (2), mark a horizontal line to leave a gap of one and one-half times the thickness of the metal at the section joint.
2. Cut the service panel along this line.
3. Drill 8 mm (5/16 in) holes for plug welding in the service part in the locations noted from the original panel.
