# Pillar Sectioning - Center

## Removal Procedure

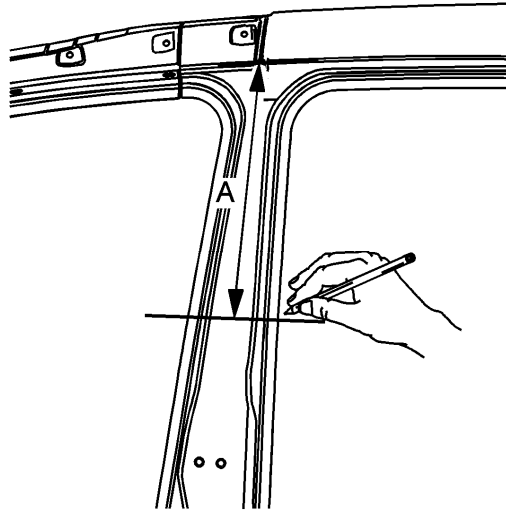
6. On the original outer door frame, measure down from the lower edge of the door opening 135 mm (5.3 in) (A) and mark a horizontal line.

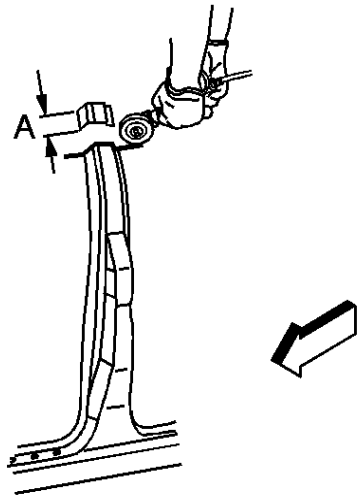
2. Create a 50-mm (2-in) backing plate (A) from the unused portion of the service part. Trim the backing plate as necessary to fit behind the sectioning joint where there is no reinforcement.
3. Drill 8-mm (5/16-in) plug weld holes along the sectioning cut on the remaining original part. Locate these holes 13 mm (1/2 in) from the edge and spaced 40 mm (1½ in) apart.

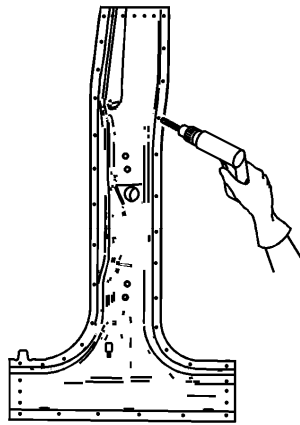
4. Drill 8-mm (5/16-in) plug weld holes in the service part as necessary in the locations noted from the original panel and along the sectioning cut.
5. Prepare all mating surfaces as necessary.
6. Apply GM-approved Weld-Thru Coating or equivalent to all mating surfaces. Refer to [Anti-Corrosion Treatment and Repair](#) .

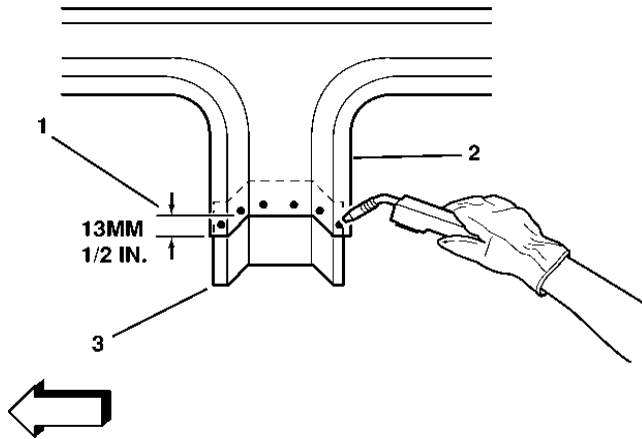
7. Fit the backing plate halfway into the sectioning joint, clamp and plug weld to the vehicle.
8. Position the center pillar.

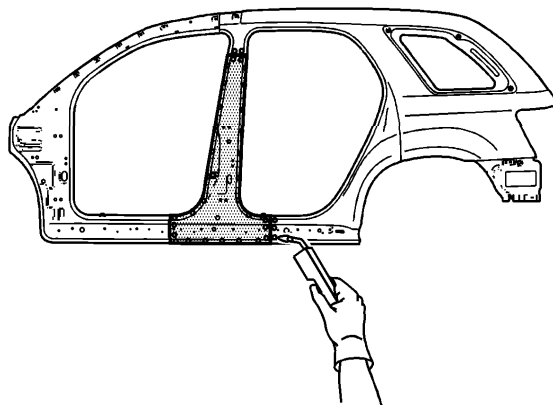
9. Plug weld accordingly.

To create a solid weld with minimum heat distortion make 25-mm (1-in) stitch welds along the seam with 25-mm (1-in) gaps between. Then go back and complete the stitch weld.

10. Stitch the weld sectioning joint.
11. Clean and prepare all welded surfaces.
12. Apply the sealers and anti-corrosion materials to the repair area, as necessary. Refer to [Anti-Corrosion Treatment and Repair](#) in Paint/Coatings.
13. Paint and repair the area. Refer to [Basecoat/Clearcoat Paint Systems](#) in General Information.
14. Install all related panels and components.
15. Connect the negative battery cable. Refer to [Battery Negative Cable Disconnect/Connect Procedure](#) in Engine Electrical.
16. Enable the SIR system. Refer to [SIR Disabling and Enabling Zones](#) in SIR.
