Front Inner Hinge Pillar Sectioning

Removal Procedure

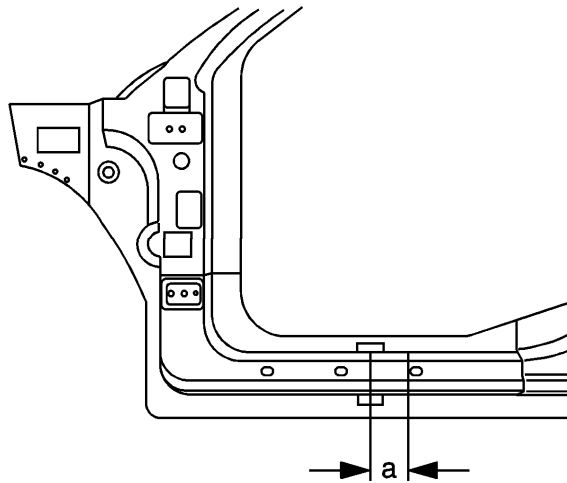
6. On the inner rocker panel, measure 50 mm (2 in) (a) forward from the front edge of the third rearward hole. This is the cut line.

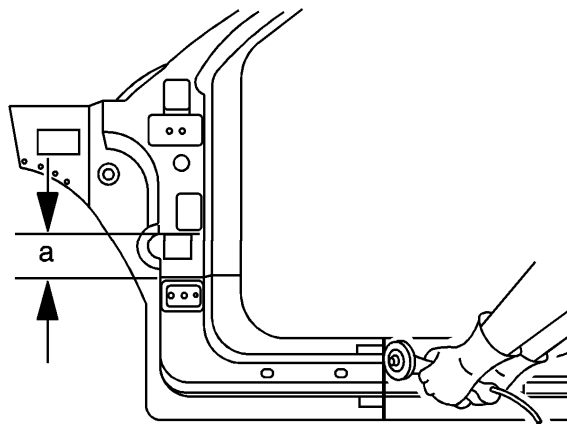
Important: Do not damage any inner reinforcements or panels.

7. Cut the panel where sectioning is to be performed.
8. Measure down 80 mm (3.25 in) (a) from the door wiring conduit hole lower edge. This is the cut line.

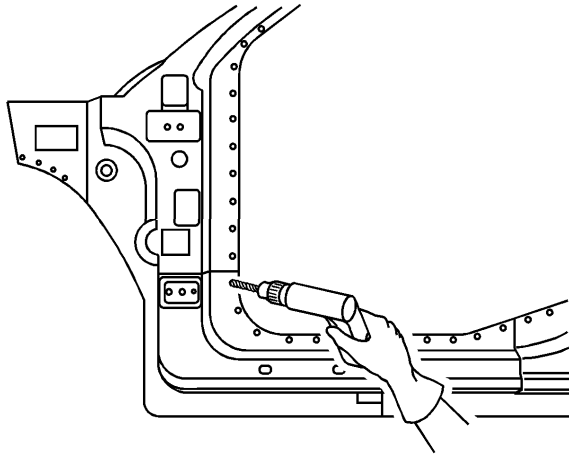
Important: Note the number and location of the factory welds for installation of the hinge pillar.

9. Locate and drill out all factory welds. Note the number and location of the welds for installation of the service part.

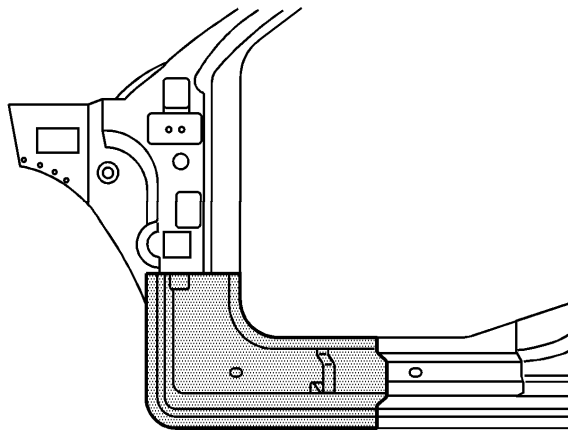
10. Remove the damaged inner hinge pillar.

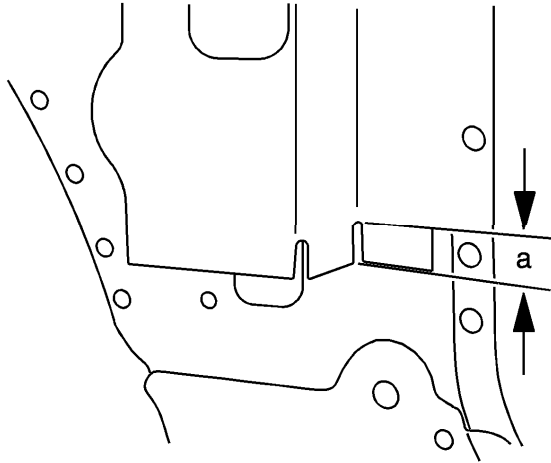
1. On the hinge pillar, after cutting, notch out the corners (a) 20 mm (0.75 in) to accept the service part fit.

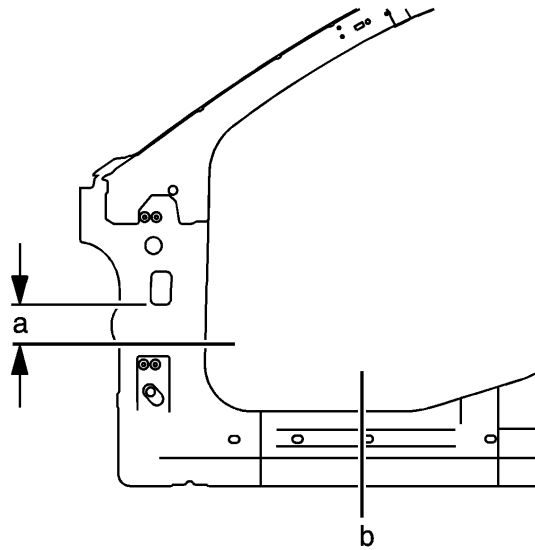
2. Measure 50 mm (2 in) (a) below the door wiring conduit hole. Cut the replacement service part horizontally.

- Cut the rocker area vertically at the front edge of the rearward hole (b).

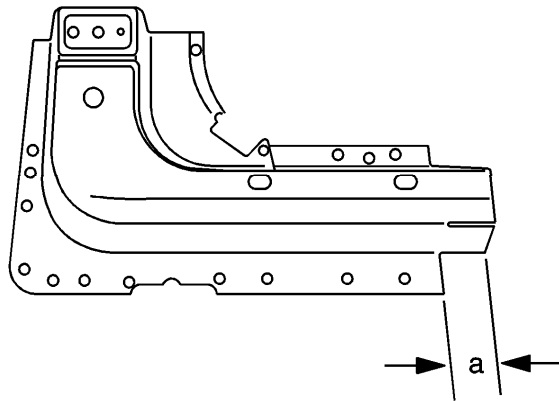
- On the service part, notch the corners back 50 mm (2 in) (a) to allow for a full underlap.

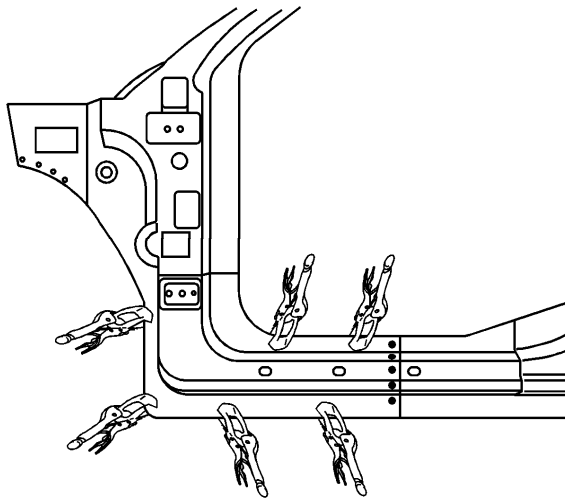
- Note the number and the location of the factory welds for installation of the service part.
- Overlap the hinge pillar area. Underlap the rocker area.

Important: If the location of the original plug weld holes can not be determined, or if structural weld-thru adhesive is present, space the plug weld holes every 40 mm (1½ in).

7. Drill 8 mm (5/16 in) plug weld holes in the service part as necessary as noted from the original panel.
8. Prepare all mating surfaces as necessary.
9. Apply GM-approved Weld-Thru Coating or equivalent to all mating surfaces. Refer to [Anti-Corrosion Treatment and Repair](#) .
10. Align service part using 3 dimensional measuring equipment. Clamp in place.

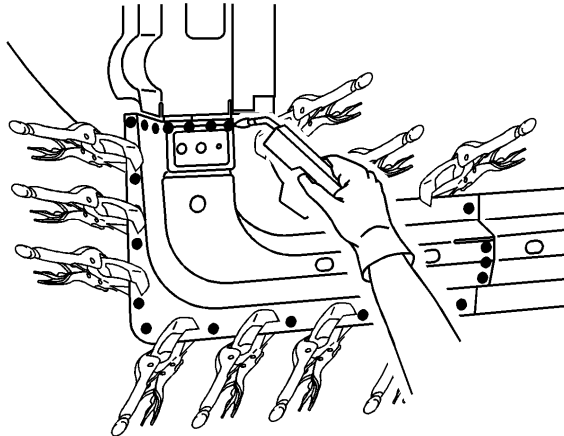
11. Add plug weld holes 1/2 in from the seam weld.
12. Weld and grind the seam.
13. Plug weld accordingly.
14. Refinish and paint the repaired area. Refer to [Basecoat/Clearcoat Paint Systems](#) .
15. Install all of the related panels and components.
16. Connect the negative battery cable. Refer to [Battery Negative Cable Disconnection and Connection](#) .
17. Enable the SIR system. Refer to [SIR Disabling and Enabling](#) .
