# Quarter Inner Panel Replacement

## Removal Procedure

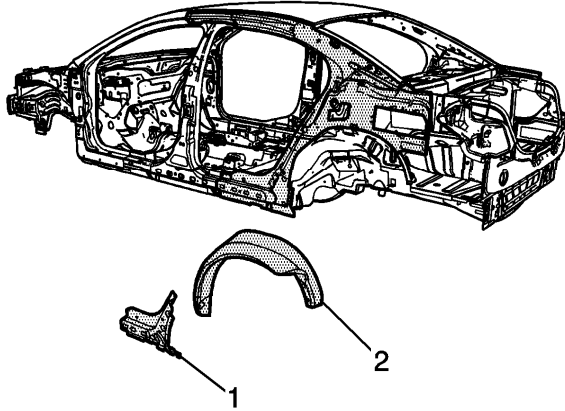
6. Remove the body inner reinforcement and the outer wheelhouse (2).

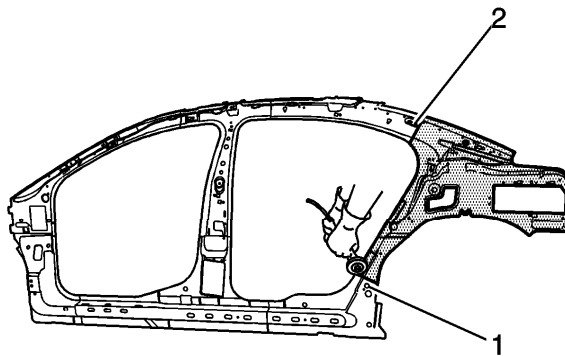
**Important:** Do not damage any inner panels or reinforcements. The rear rocker area contains a nylon reinforcement that may be replaced if damaged.

7. In the dog leg panel area, measure 100 mm (4 in) upward from the locating hole (1). Scribe a line. This is the cut line.
8. On the upper inner quarter panel area, measure 100 mm (4 in) down from the locating hole (2). This is the cut line.

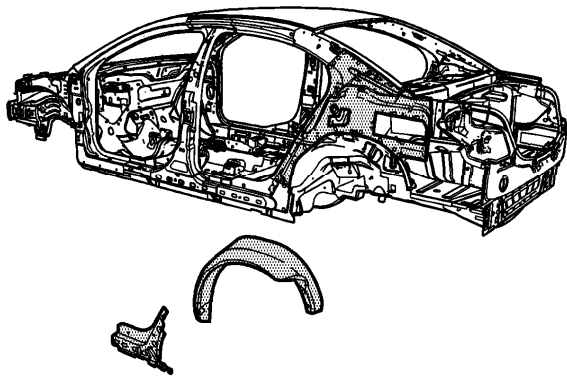
**Important:** Note the number and location of the factory welds for installation of the inner quarter panel.

9. Locate, mark, and drill out all the necessary factory welds.

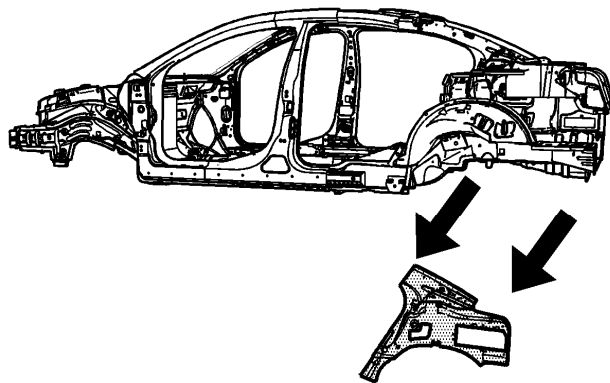
10. Remove the damaged wheelhouse section.

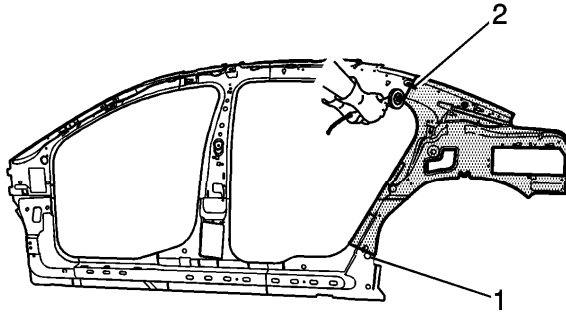
1. Cut the service part 50 mm (2 in) upward from the dog leg locating hol (1) and 50 mm (2 in) down from the upper inner locating hole (2) as noted.

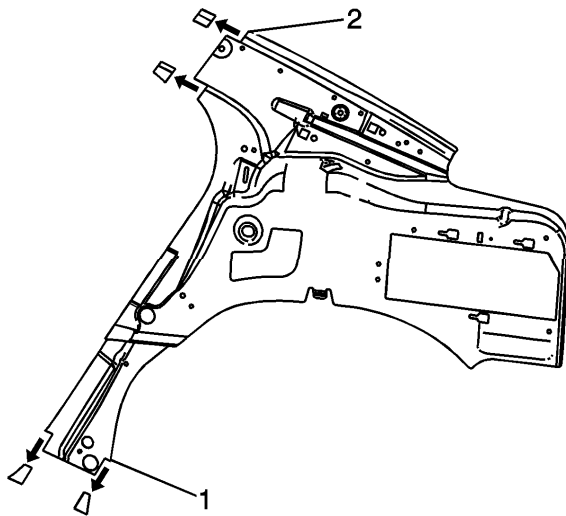
2. At the cut edge of the service panel in the dog leg area, measure upward 50 mm (2 in) (1). Notch out the upper innerr panel flange to allow the underlap to the existing panel.

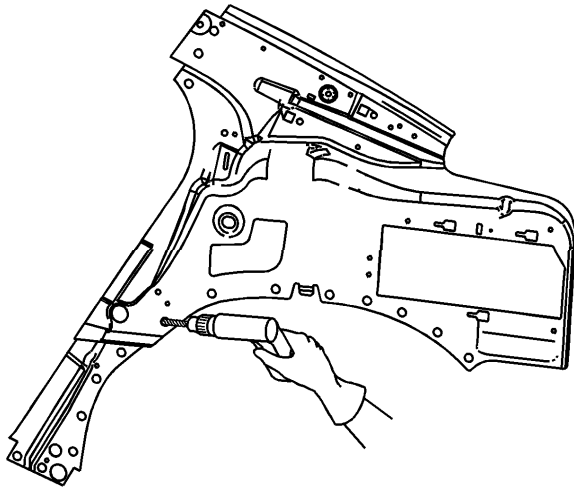
3. Drill 8 mm (5/16 in) plug weld holes along the sectioning cut on the original reinforcement. Locate these holes 25 mm (1 in) from the edge and spaced 40 mm (1½ in) apart.

**Important:** If the location of the original plug weld holes can not be determined, space the plug weld holes every 40 mm (1 1/2 in) apart.

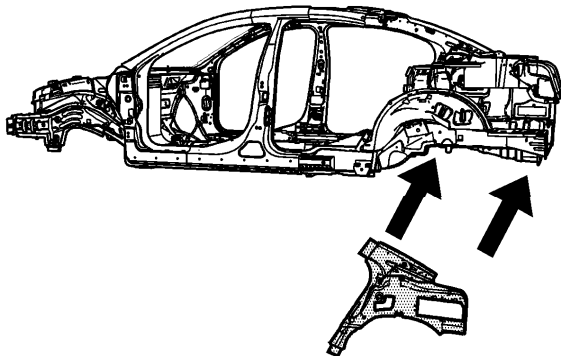
7. Align the service part on the vehicle using 3-dimensional measuring equipment.

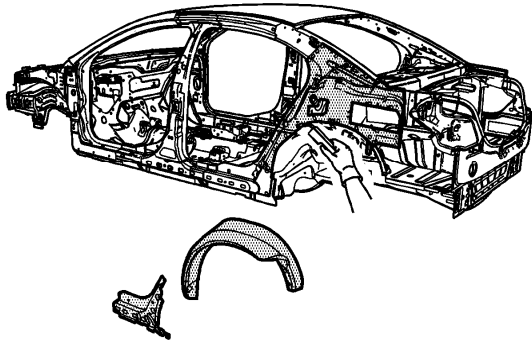
8. Plug weld accordingly.
9. To create a solid weld with minimum heat distortion, make 25 mm (1 in) stitch welds along the seam with 25 mm (1 in) gaps between them. Go back and complete the stitch weld.

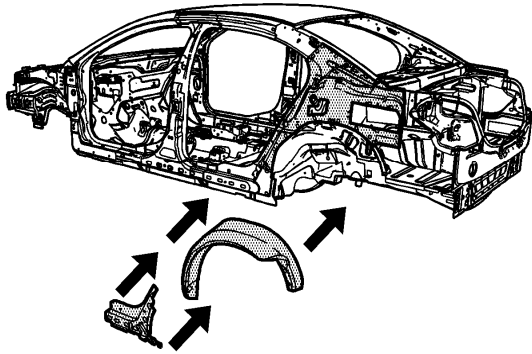
10. Install the body inner reinforcement and the outer wheelhouse.
11. Clean and prepare all of the welded surfaces.
12. Apply the sealers and anti-corrosion materials to the repair area, as necessary.  
Refer to [Anti-Corrosion Treatment and Repair](#) .
13. Paint the repaired area. Refer to [Basecoat/Clearcoat Paint Systems](#) .
14. Install all of the related panels and components.
15. Connect the negative battery cable. Refer to [Battery Negative Cable Disconnection and Connection](#) .
16. Enable the SIR system. Refer to [SIR Disabling and Enabling](#) .
