Rail Underbody Gusset Replacement - Rear

Removal Procedure

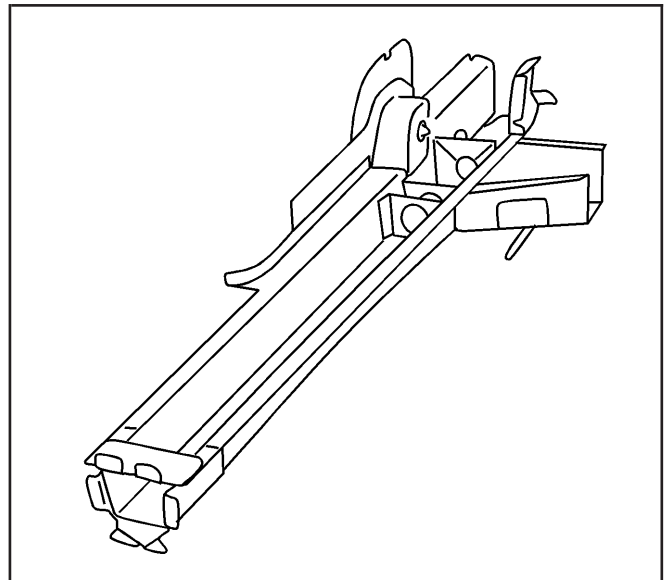
874146

2. Disconnect the negative battery cable.
3. Remove all related panels and components.
4. Repair as much of the damage as possible. Refer to *Dimensions - Body* on page 3-7.
5. Remove the sealers and anti-corrosion materials from the repair area, as necessary.

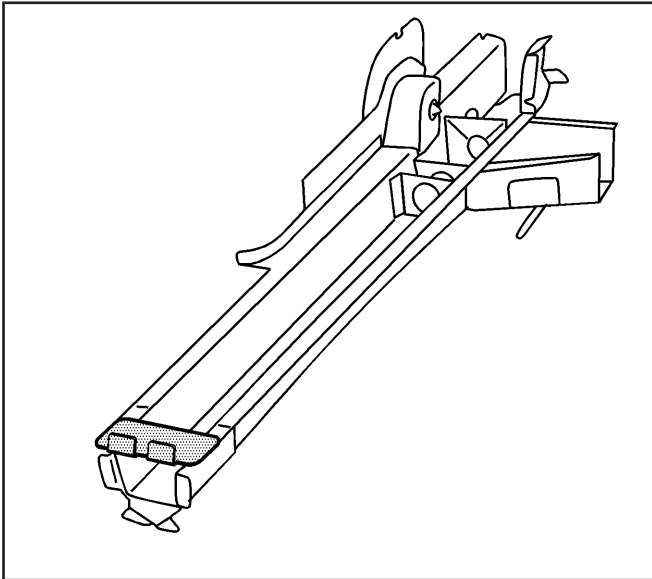
874152

Important: Note the number and location of the factory welds for installation of the underbody gusset to the rear rail.

6. Locate and drill out all the necessary factory welds.

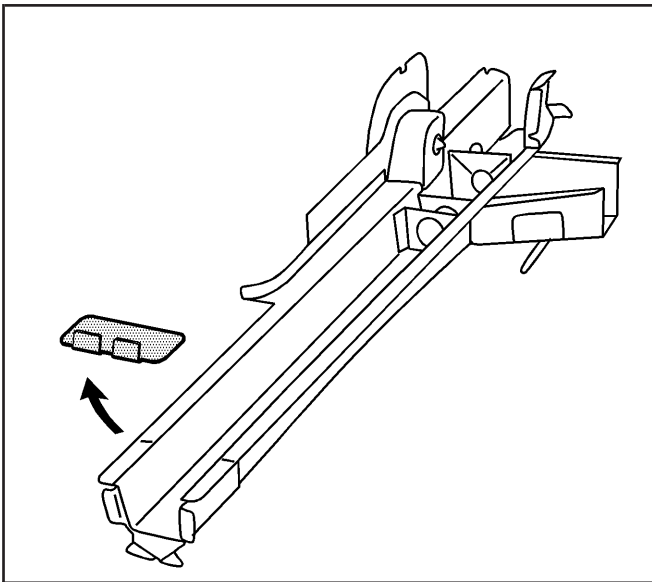
874156

7. Remove the underbody gusset from the rear rail.

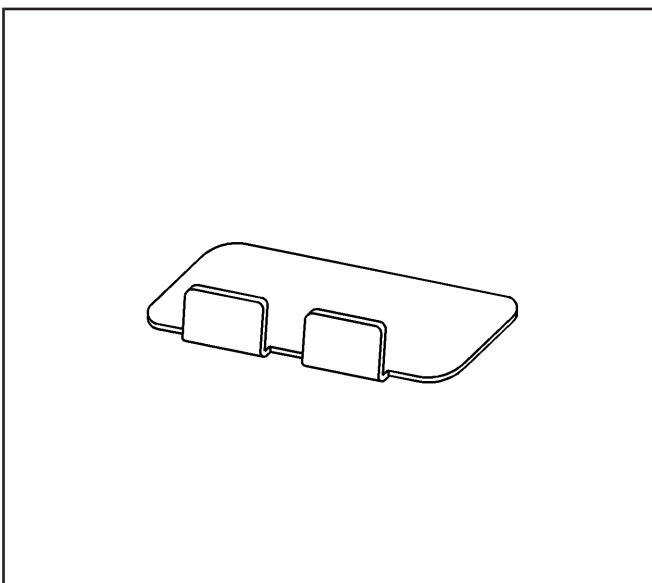
874149

Important: If the location of the original plug weld holes can not be determined, space the plug weld holes every 40 mm (1½ in) apart.

1. Drill 8 mm (5/16 in) plug weld holes in the service part as necessary in the corresponding locations noted on the original panel.
2. Prepare all mating surfaces as necessary.
3. Apply 3M® Weld-Thru coating P/N 05916 or equivalent to all mating surfaces.

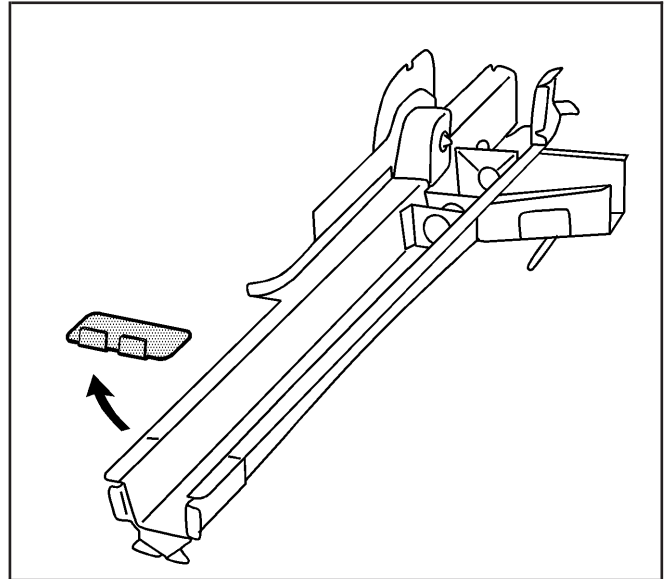
874156

4. Position the underbody gusset to the rear rail.

5. Plug weld accordingly.
6. Clean and prepare all of the welded surfaces.
7. Install all of the related panels and components.
8. Apply the sealers and anti-corrosion materials to the repair area, as necessary.
9. Paint the repaired area.
10. Connect the negative battery cable.
11. Enable the SIR system.
