# Tie Bar Assembly

## Removal Procedure

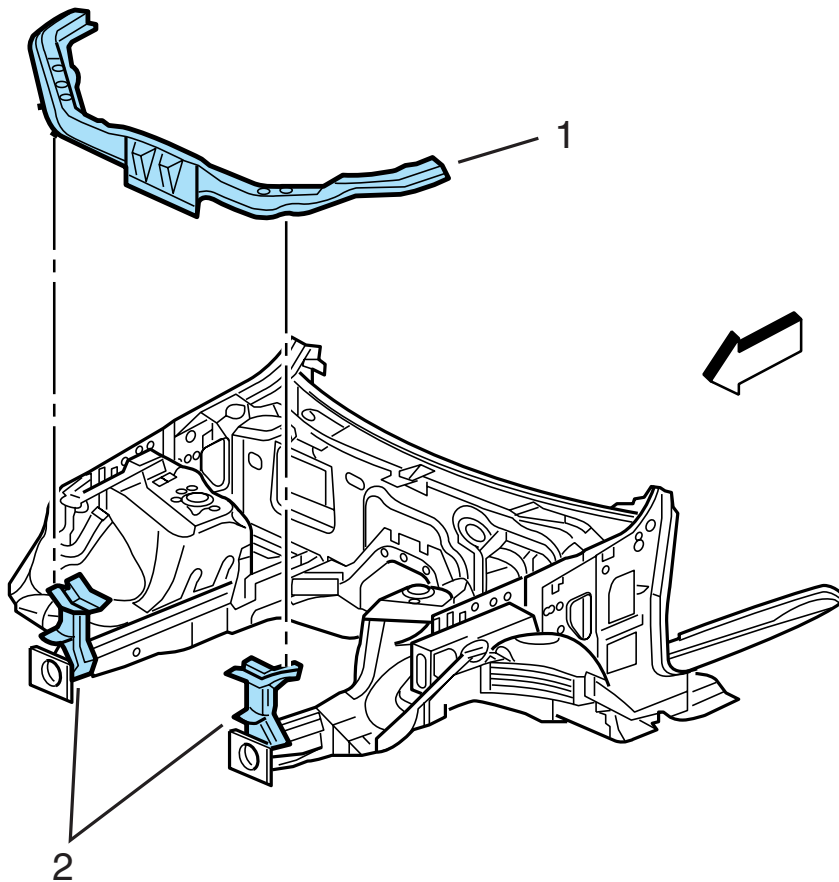
**IMPORTANT:** The front upper tie bar is serviced as 3 components: Right and left side tie bar reinforcements (2) and the upper tie bar (1).

1. Disable the SIR system. Refer to Disabling the SIR System in Cautions and Notices.
2. Disconnect the negative battery cable. Refer to Battery Negative Cable Disconnect/Connect Procedure in Cautions and Notices.
3. Remove all related panels and components.
4. Restore as much of the damage as possible.
5. Remove the sealers and anti-corrosion materials from the repair area, as necessary. Refer to Anti-Corrosion Treatment and Repair in Cautions and Notices.
6. Locate, mark, and drill out all factory welds attaching the upper tie bar (1) and reinforcements (2) if necessary.
7. Remove the damaged tie bar (1).

**IMPORTANT:** If the original locations are damaged beyond recognition, locate holes for plug welding 40 mm (1-1/2 in.) apart.
3. Temporarily position the upper tie bar (1) and reinforcements (2) on the vehicle.
