Front Compartment Upper Side Rail Replacement

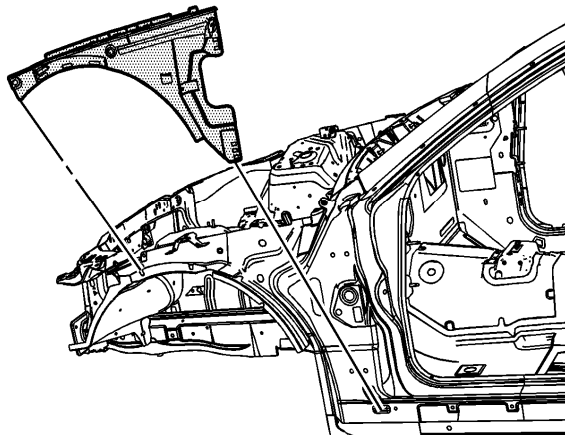
Important: Sectioning of the front upper rails is not recommended.

3. Remove all related panels and components.
4. Restore as much of the damage as possible .

5. Remove the sealers and anti-corrosion materials from the repair area, as necessary. Refer to [Anti-Corrosion Treatment and Repair](#) .
6. Locate, mark, and drill out all factory welds attaching the outer rail.
7. Remove the damaged outer rail.

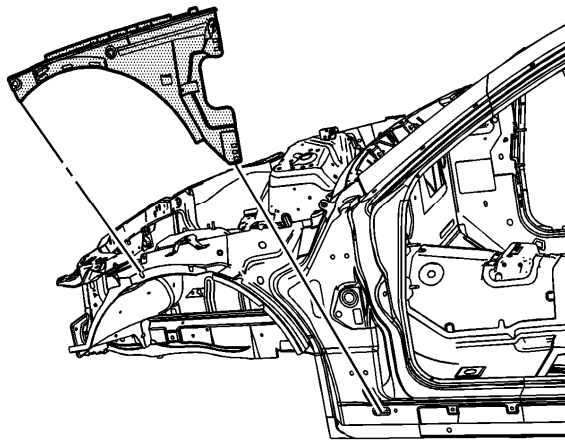
1. Prepare the mating surfaces as necessary.
2. Apply Weld-Thru Coating to all mating surfaces. Refer to [Anti-Corrosion Treatment and Repair](#) .

Important: If the location of the original plug weld holes can not be determined, or if structural weld-thru adhesive is present, space the plug weld holes every 40 mm (1½ in).

3. Drill 8 mm (5/16 in) plug weld holes as necessary in the locations noted from the original panels.
4. Temporarily position the outer rail on the vehicle.
5. Verify the location using 3-dimensional measuring equipment.
6. Plug weld accordingly.
7. Clean and prepare welded surfaces.
8. Apply the sealers and anti-corrosion materials to the repair area, as necessary. Refer to [Anti-Corrosion Treatment and Repair](#) .
9. Paint the repaired area. Refer to [Basecoat/Clearcoat Paint Systems](#) .
