Front Inner Hinge Pillar Body Replacement

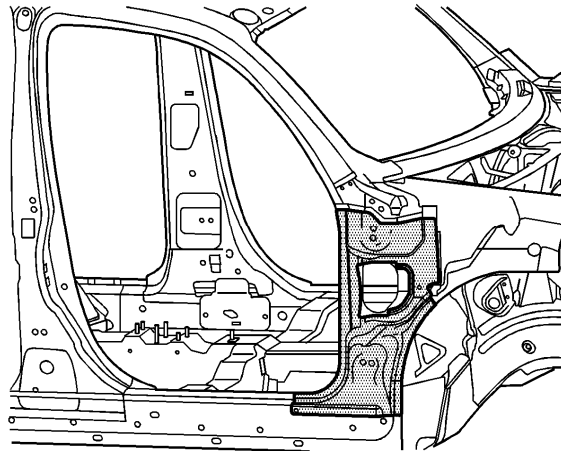
5. Remove the sealers and anti-corrosion materials from the repair area, as necessary. Refer to [Anti-Corrosion Treatment and Repair](#) .

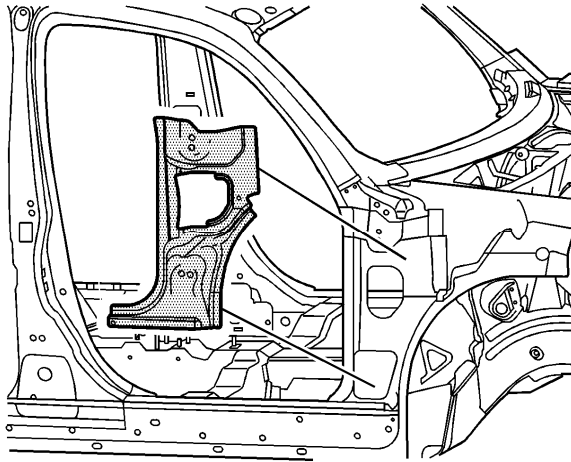
7. Remove the inner hinge pillar.

Important: Note the number and location of the factory welds for installation of the inner hinge pillar.

6. Locate and drill out all the necessary factory welds.

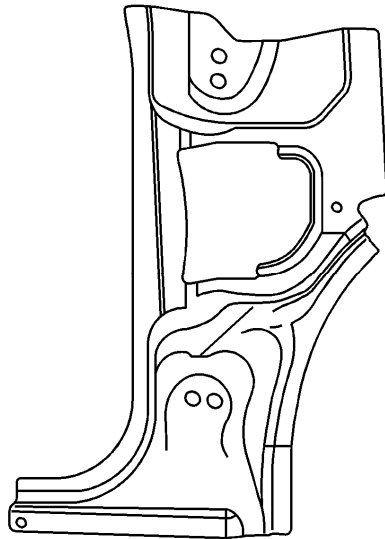
Important: If the location of the original plug weld holes can not be determined, space the plug weld holes every 40 mm (1½ in) apart.

1. Drill 8 mm (5/16 in) plug weld holes in the service part as necessary in the locations noted from the original panel.
2. Prepare all mating surfaces as necessary.
3. Apply GM-approved Weld-Thru Coating or equivalent to all mating surfaces. Refer to [Anti-Corrosion Treatment and Repair](#) .

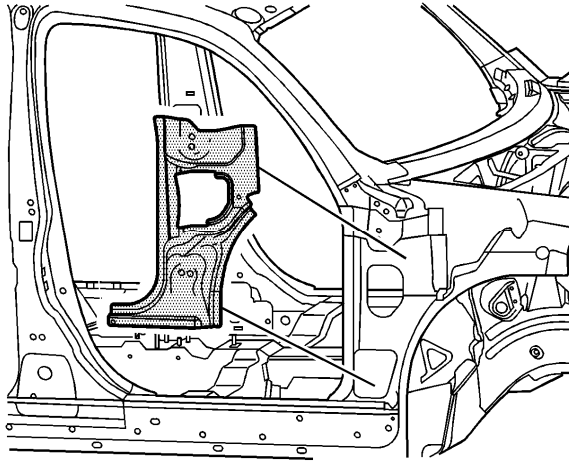
4. Position the hinge pillar body to the vehicle using 3-dimensional measuring equipment and clamp the panel in place.

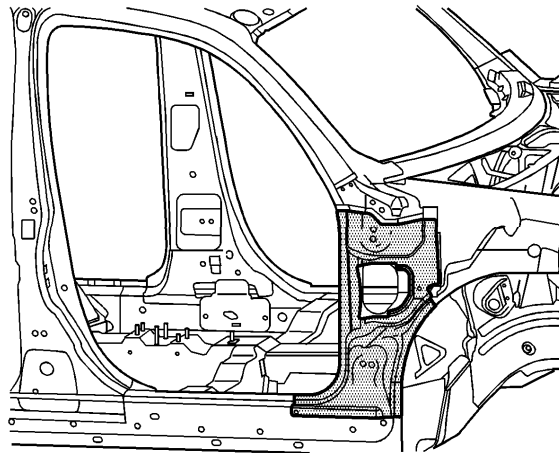
5. Plug weld accordingly.
6. Clean and prepare all of the welded surfaces.
7. Install all of the related panels and components.
8. Apply the sealers and anti-corrosion materials to the repair area, as necessary. Refer to [Anti-Corrosion Treatment and Repair](#) .
