Radiator Support Replacement

Removal Procedure

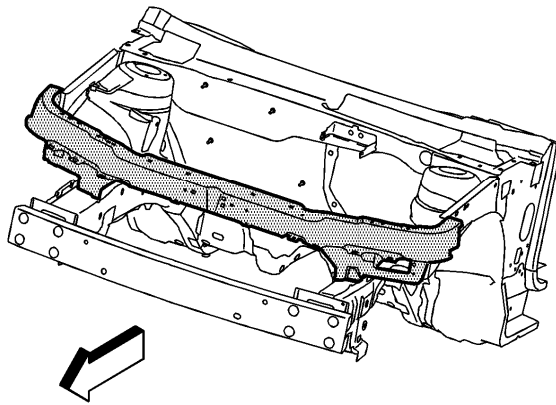
1. Disable the SIR system. Refer to [SIR Disabling and Enabling Zones](#) .
2. Disconnect the negative battery cable. Refer to [Battery Negative Cable Disconnect/Connect Procedure](#) .

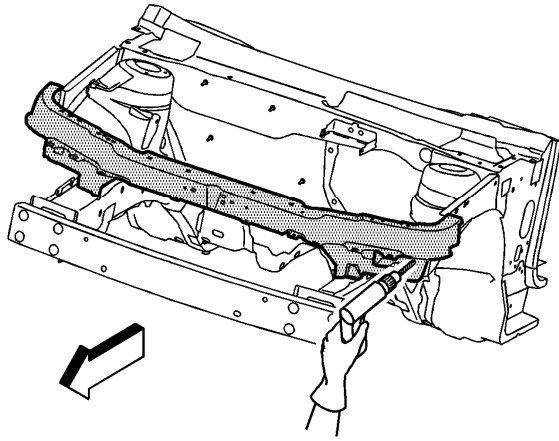
3. Remove all related panels and components.
4. Repair as much of the damage as possible to factory specifications. Refer to [Dimensions - Body](#) .
5. Note the location and remove the sealers and anti-corrosion materials from the repair area, as necessary. Refer to [Anti-Corrosion Treatment and Repair](#) .

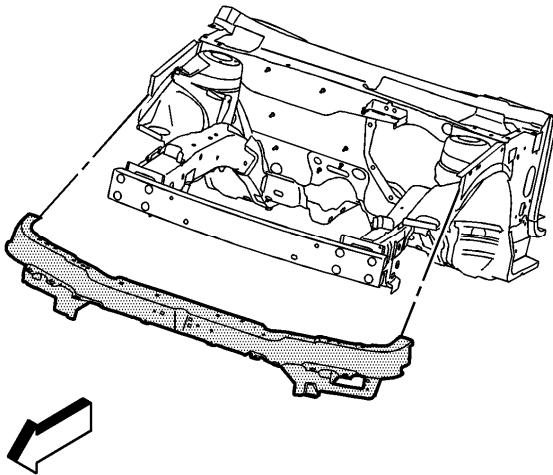
Important: Do not damage any inner panels or reinforcements.

6. Locate and drill out all factory welds. Note the number and location of the welds for installation of the tie bar.

7. Remove the damaged tie bar.

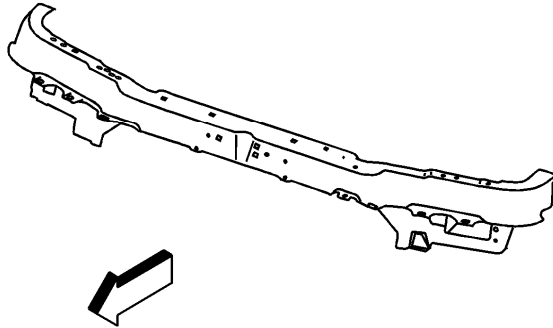
Important: If the location of the original plug weld holes can not be determined, space the plug weld holes every 40 mm (1 1/2 in) apart.

1. Drill 8 mm (5/16 in) plug weld holes in the service part as necessary in the locations noted from the original panel.
2. Prepare all mating surfaces as necessary.
3. Apply GM-approved Weld-Thru Coating or equivalent to all mating surfaces. Refer to [Anti-Corrosion Treatment and Repair](#).

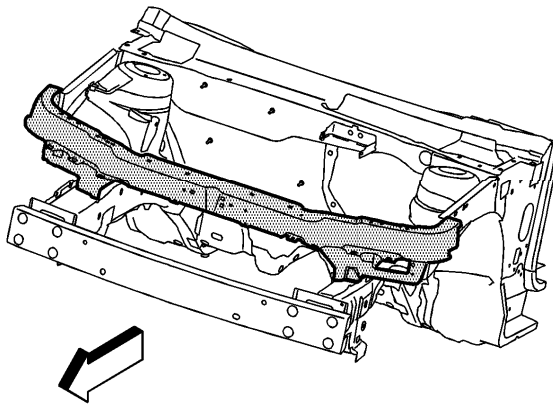
4. Position the tie bar to the vehicle using 3-dimensional measuring equipment.
Clamp the tie bar into place.
5. Plug weld accordingly.
6. Clean and prepare all welded surfaces.
7. Apply the sealers and anti-corrosion materials to the repair area, as necessary.
Refer to [Anti-Corrosion Treatment and Repair](#) .
8. Paint the repair area. Refer to [Basecoat/Clearcoat Paint Systems](#) .
9. Install all related panels and components.
10. Connect the negative battery cable. Refer to [Battery Negative Cable Disconnect/Connect Procedure](#) .
11. Enable the SIR system. Refer to [SIR Disabling and Enabling Zones](#) .
