Impact Bar Anchor Plate Replacement - Rear Bumper

Removal Procedure

Installation Procedure

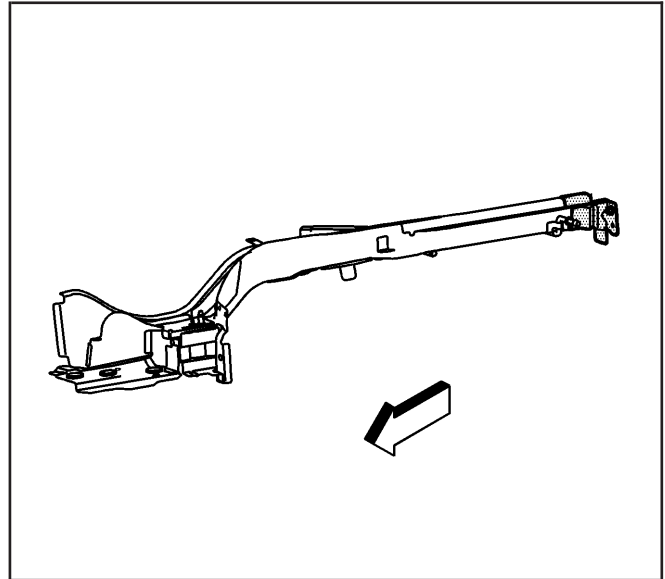
1203191

Important: Note the number and location of the factory welds for installation of the rear rail assembly rear extension.

6. Locate and drill out all the necessary factory welds.

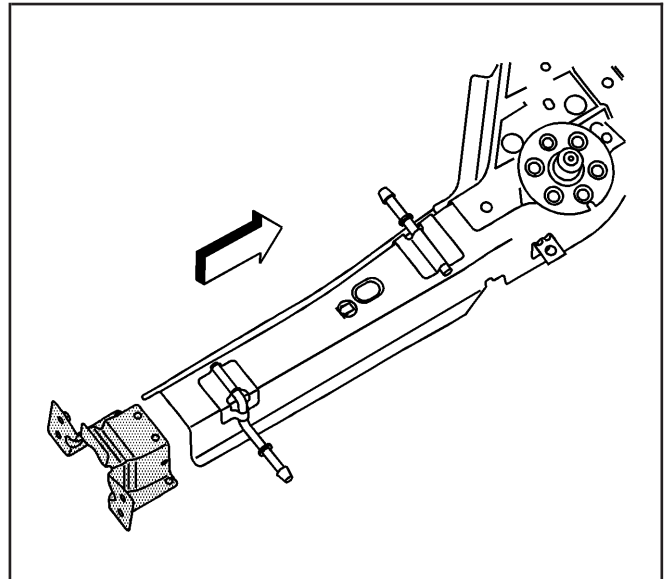
1203207

7. Remove the rear rail assembly rear extension.

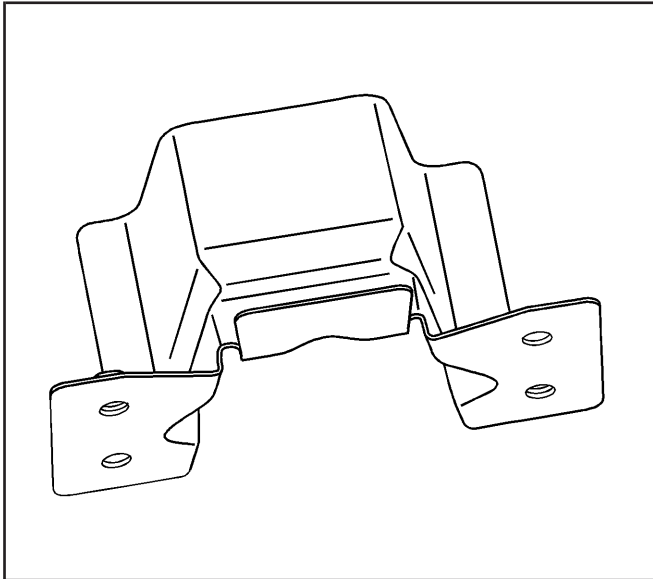
1203233

1. Drill 8 mm (5/16 in) plug weld holes in the service part as necessary in the corresponding locations noted on the original panel.
2. Prepare all mating surfaces as necessary.
3. Apply 3M® Weld-Thru coating P/N 05916 or equivalent to all mating surfaces.

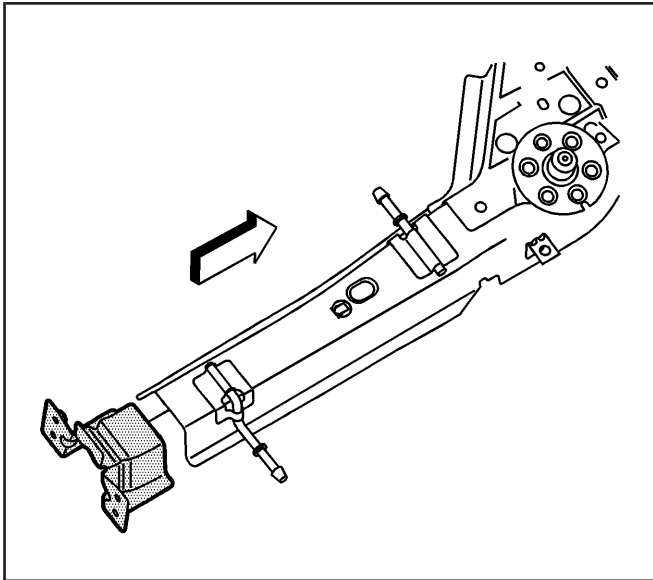
1203223

4. Position the anchor plate to the rear rail.

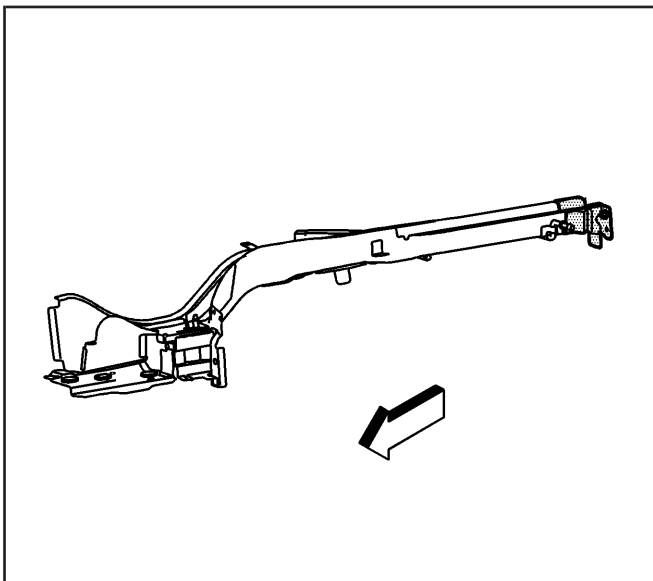
1203191

5. Plug weld accordingly.
6. Clean and prepare all of the welded surfaces.
7. Install all of the related panels and components.
8. Apply the sealers and anti-corrosion materials to the repair area, as necessary. Refer to *Anti-Corrosion Treatment and Repair*.
9. Paint the repaired area. Refer to *Basecoat/Clearcoat Paint Systems*.
