Tie Bar Replacement

Removal Procedure

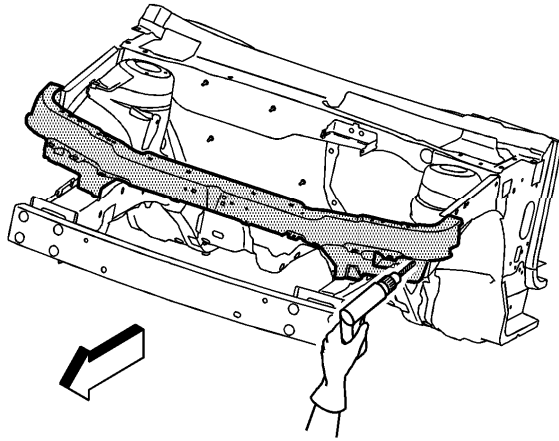
6. Locate and drill out all factory welds. Note the number and location of the welds for installation of the tie bar.

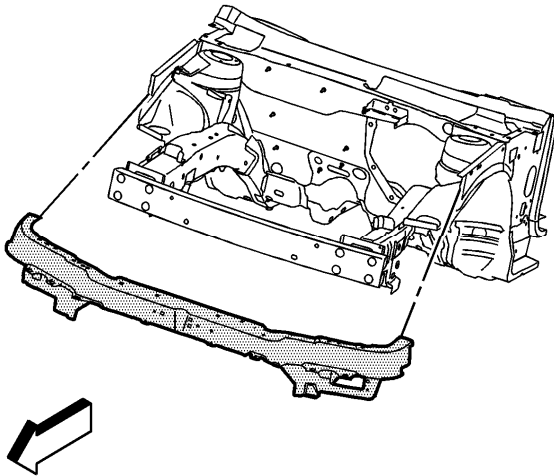
7. Remove the damaged tie bar.

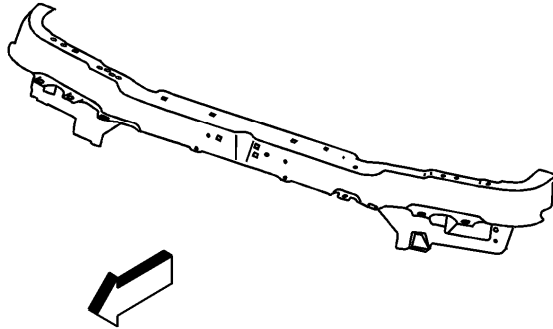
Important: If the location of the original plug weld holes can not be determined, space the plug weld holes every 40 mm (1 1/2 in) apart.

1. Drill 8 mm (5/16 in) plug weld holes in the service part as necessary in the locations noted from the original panel.
2. Prepare all mating surfaces as necessary.
3. Apply GM-approved Weld-Thru Coating or equivalent to all mating surfaces. Refer to [Anti-Corrosion Treatment and Repair](#) .

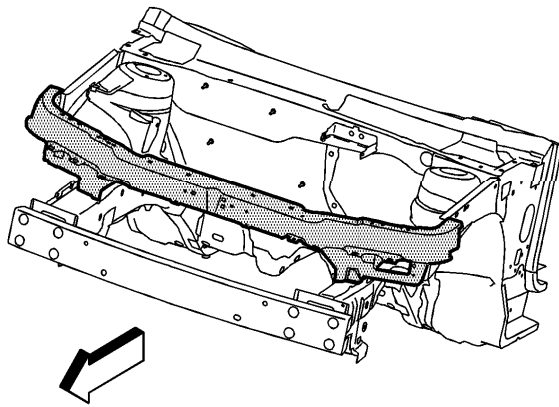
4. Position the tie bar to the vehicle using 3-dimensional measuring equipment. Clamp the tie bar into place.
5. Plug weld accordingly.
6. Clean and prepare all welded surfaces.
7. Apply the sealers and anti-corrosion materials to the repair area, as necessary. Refer to [Anti-Corrosion Treatment and Repair](#) .
8. Paint the repair area. Refer to [Basecoat/Clearcoat Paint Systems](#) .
9. Install all related panels and components.
10. Connect the negative battery cable. Refer to [Battery Negative Cable Disconnection and Connection](#) .
11. Enable the SIR system. Refer to [SIR Disabling and Enabling](#) .
